CEMETERY SURVEY FORM

SITE NAME: Satala Naval Cemetery

PLOT IDENTIFICATION: 52

NAME(S) OF INTERRED: Child of J. F. Crowell

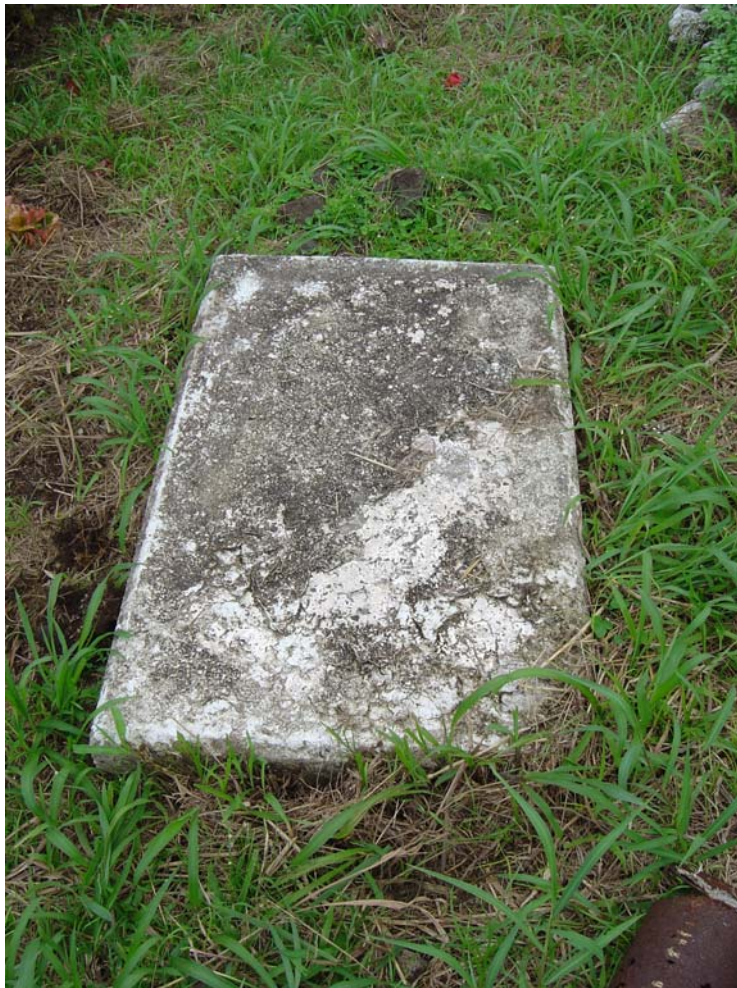
PLOT: 52

SUMMARY: White paint and mildew on concrete portion; basalt rock mound marker overgrown with grass; concrete portion looks misplaced or relocated.
