CEMETERY SURVEY FORM

SITE NAME: Satala Naval Cemetery

PLOT IDENTIFICATION: 54

NAME(S) OF INTERRED: FRANK UHRLE

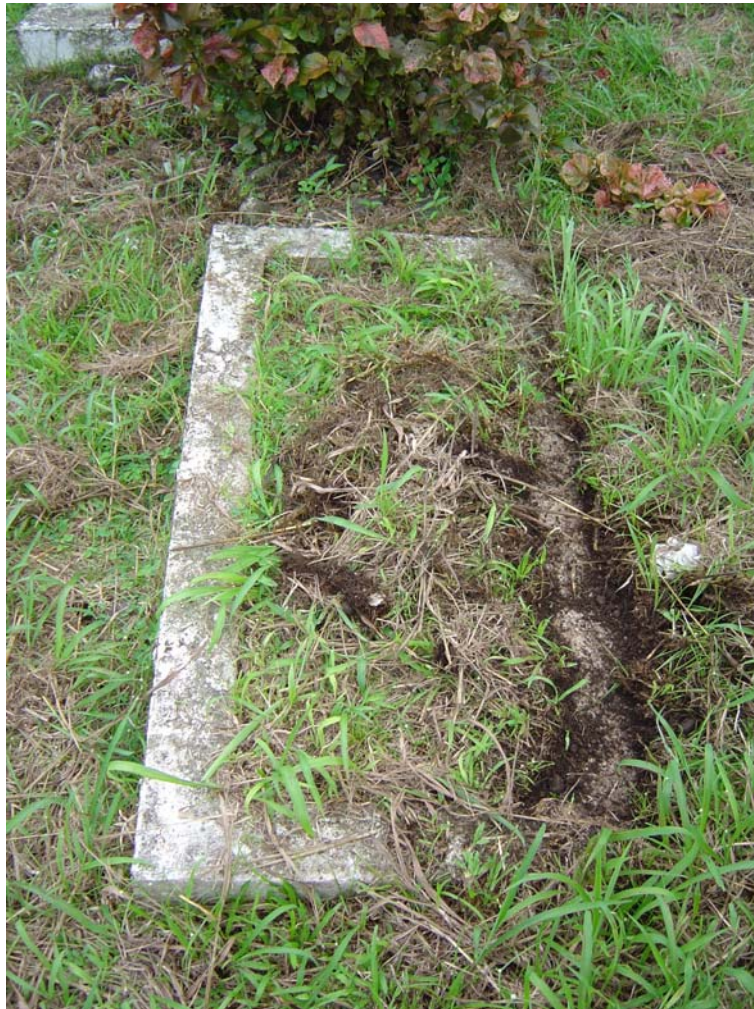
PHOTO:

hazardous/immediate action **unstable deterioration/ASAP**

SUMMARY: Open top bedstead style with embedded containers at head and foot.

Flaking white paint; NE corner not visible sinking or overgrown rock mound under bush
at W end of bedstead possible marker?
