CEMETERY SURVEY FORM

SITE NAME: Satala Naval Cemetery

PLOT IDENTIFICATION: 56

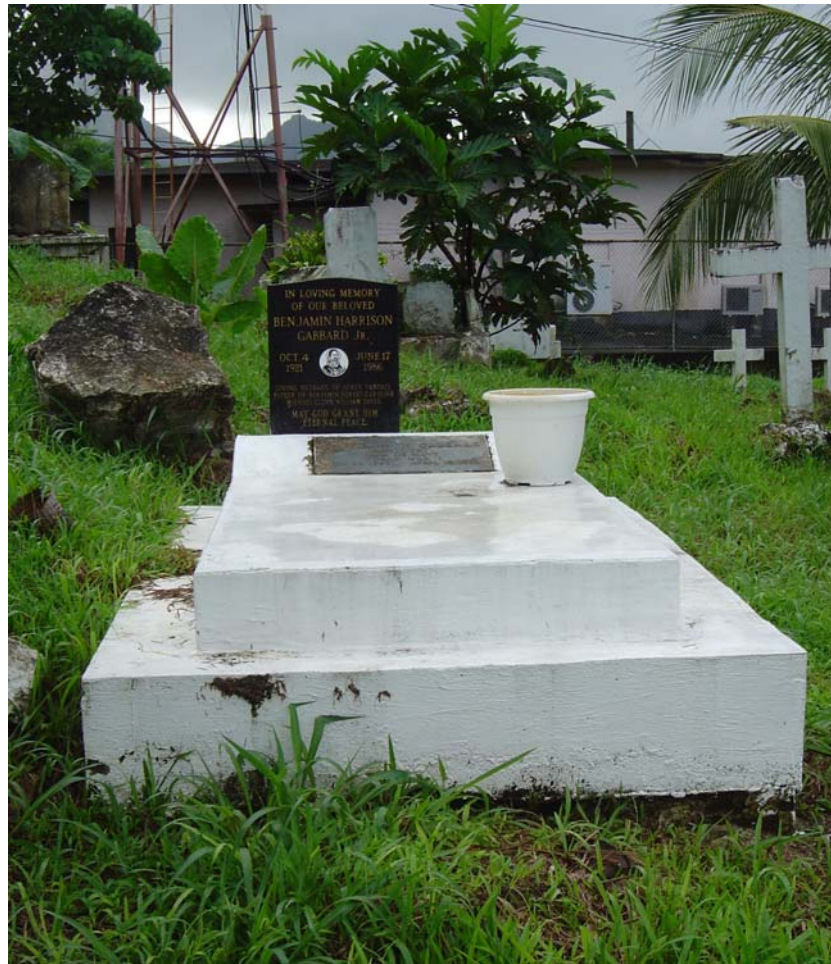
PLOT: 56

SUMMARY: Grave maintained by family, no work needed.
