CEMETERY SURVEY FORM

SITE NAME: Satala Naval Cemetery

LOCATION: Maoputasi County, Tutuila Island, American Samoa

PLOT IDENTIFICATION: 57

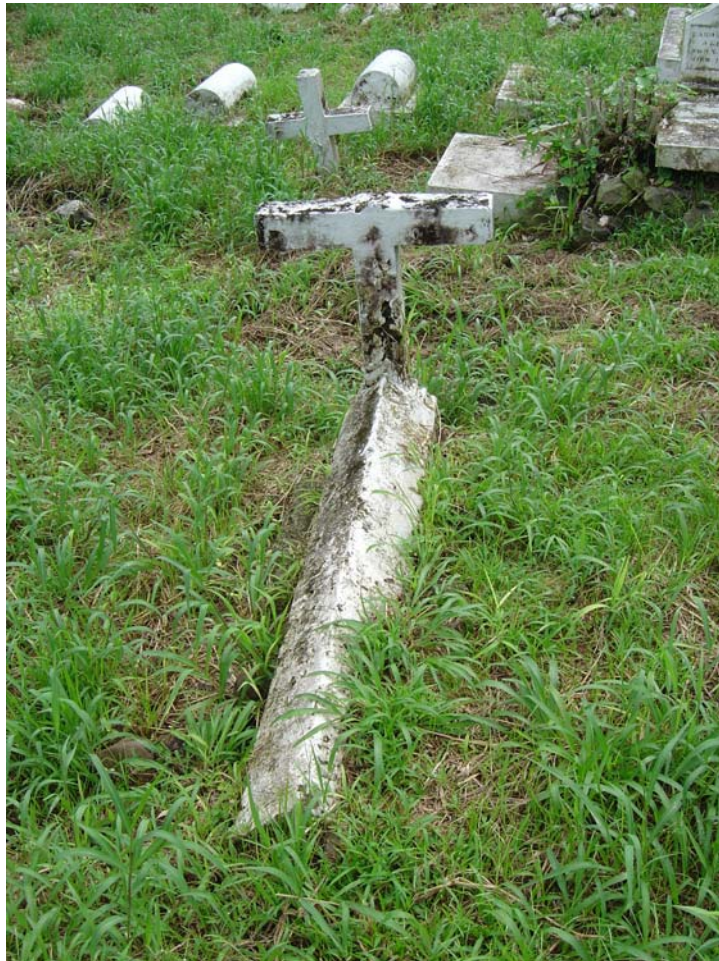
PHOTO:

SUMMARY: Base eroding out; entire structure sliding downhill. Cross top broken off – missing, large chunks missing from all over. All covered in mildew and thick white paint. Chips missing out of primary structure.

hazardous/immediate action **unstable deterioration/ASAP**
