CEMETERY SURVEY FORM

SITE NAME: Satala Naval Cemetery

PLOT IDENTIFICATION: 59

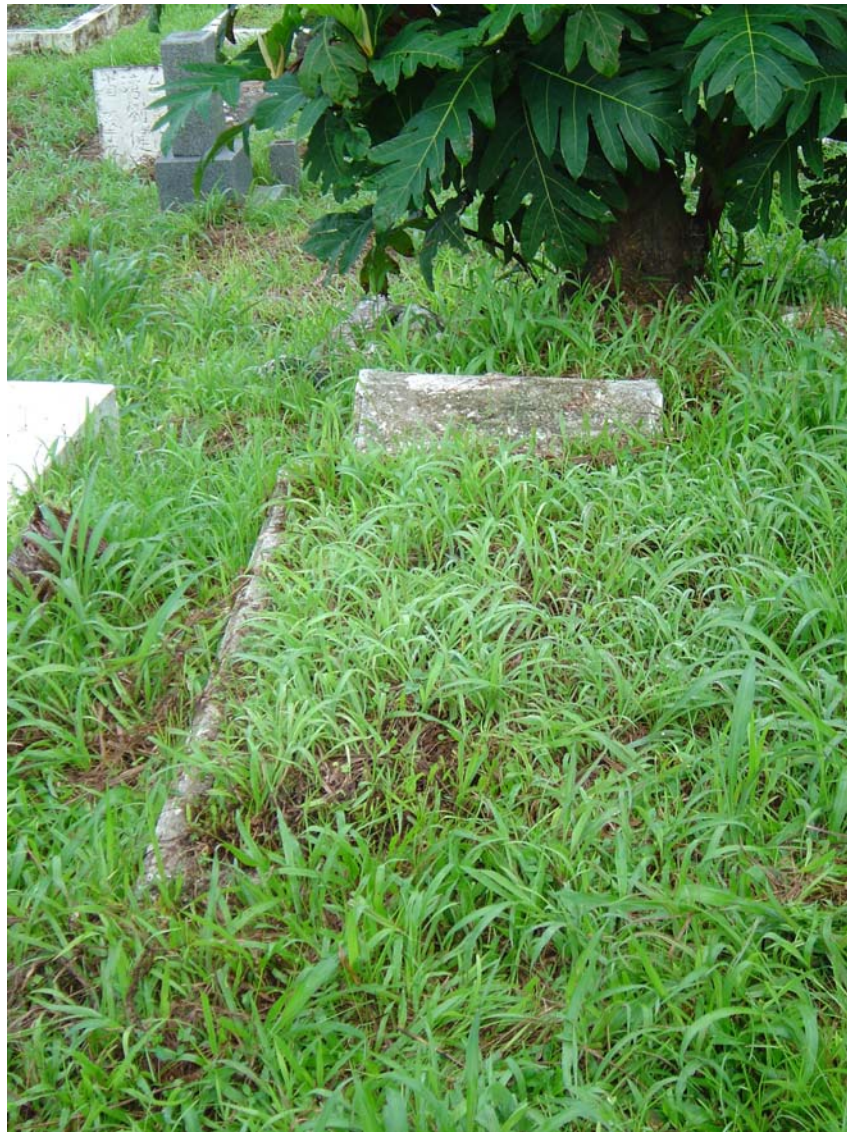
PHOTO:

SUMMARY: Covered in flaking white paint; open top bedstead style filled with waterworn basalt cobbles. Severely overgrown on N side and inside.

PAIN'T REMOVAL
