CEMETERY SURVEY FORM

SITE NAME: Satala Naval Cemetery

LOCATION: Maoputasi County, Tutuila Island, American Samoa

PLOT IDENTIFICATION: 6

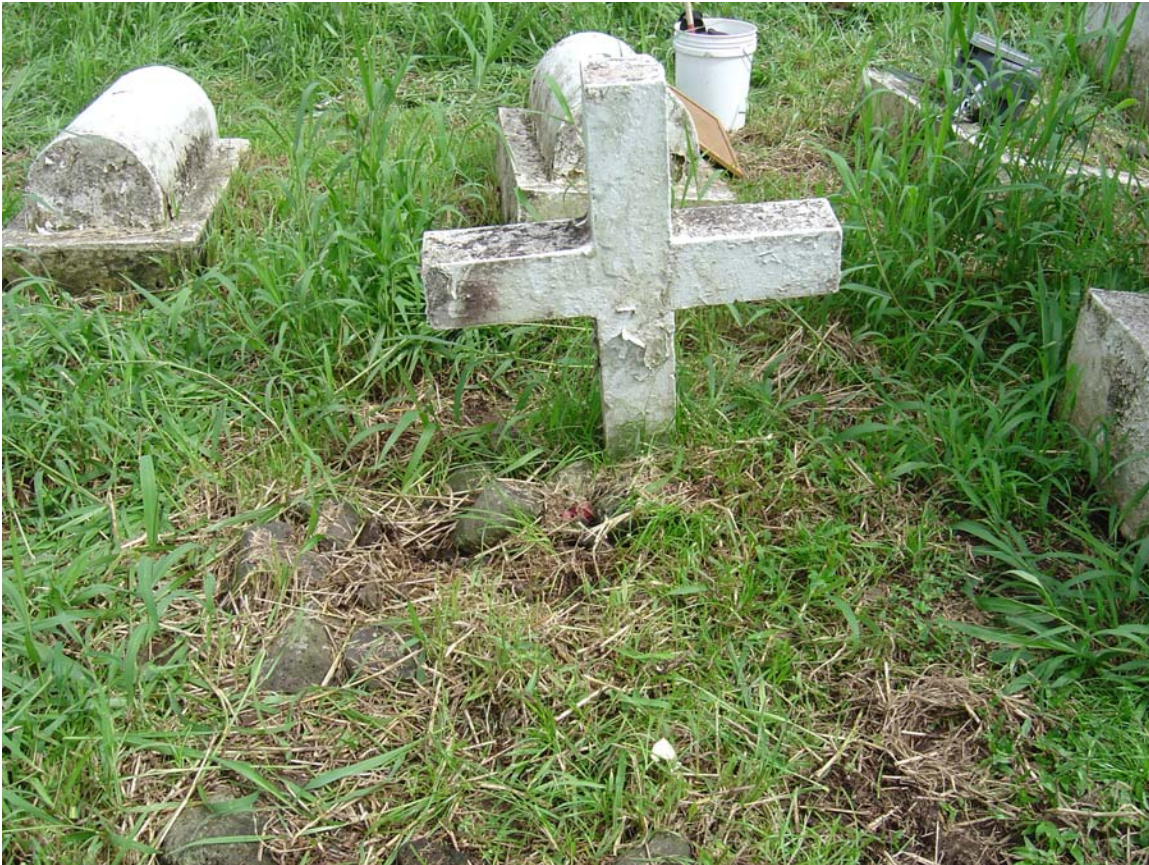
PHOTO:

SUMMARY: Completely overgrown, partially buried in 2003 flood. Cross is chipped, partially buried, and tilted.

hazardous/immediate action **unstable deterioration/ASAP**
