CEMETERY SURVEY FORM

SITE NAME: Satala Naval Cemetery

LOCATION: Maoputasi County, Tutuila Island, American Samoa

PLOT IDENTIFICATION: 61A

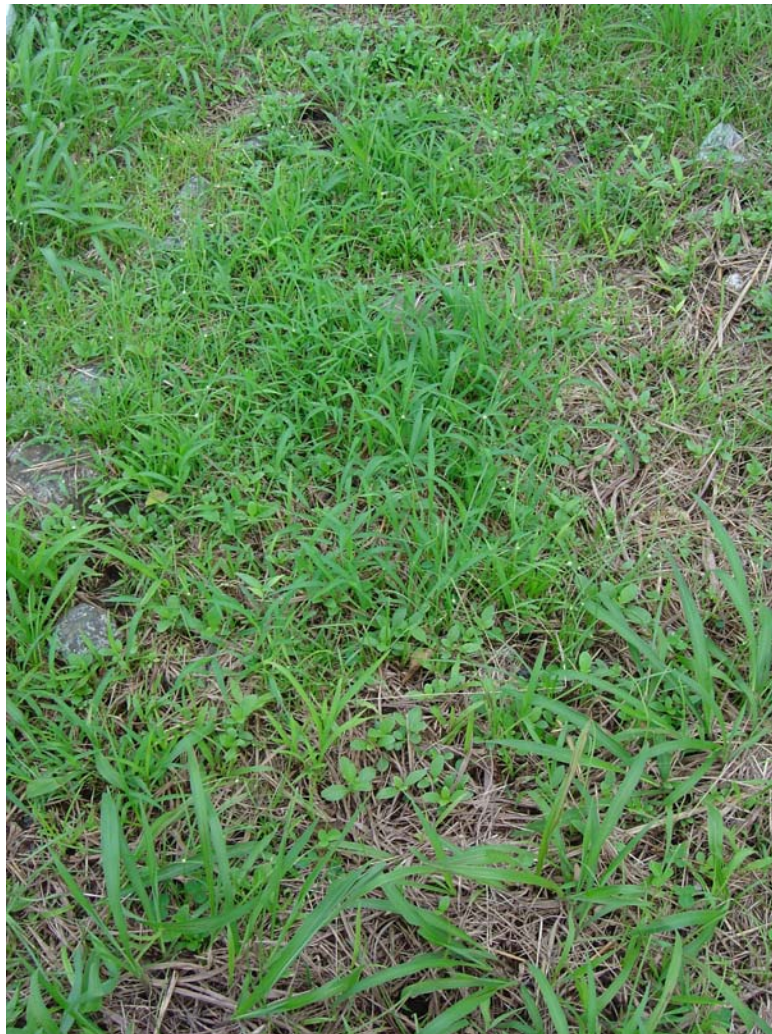
PHOTO:

EXISTING CONDITION	CONSERVATION STRATEGY
<p>POSITION: fallen unstable overgrown tilted marker/ base other <u>sunken</u></p> <p>DETERIORATION: ----- broken cracked losses flaking/sugaring delaminations/detachment other _____</p> <p>SOILING: ----- biological general graffiti efflorescence painting other</p> <p>FAILED TREATMENTS: metal adhesives/coatings mortar other _____</p>	<p>POSITION: reset in ground reset to existing base resquare botom edge remove fragments in setting slot construct new base possible new base required stabilize foundation</p> <p>DETERIORATION: structural adhesion repair mortars crack fillers flowable grouts consolidation</p> <p>SOILING: chemical pressure wash poultice air abrasion</p> <p>FAILED TREATMENTS: drill/grind hand tools solvents air abrasion</p>

SUMMARY: Rock outline/mound overgrown with vegetation; sunken center. Some roots painted white.
