CEMETERY SURVEY FORM

SITE NAME: Satala Naval Cemetery

PLOT IDENTIFICATION: 61B

NAME(S) OF INTERRED: ERLING PEDERSON

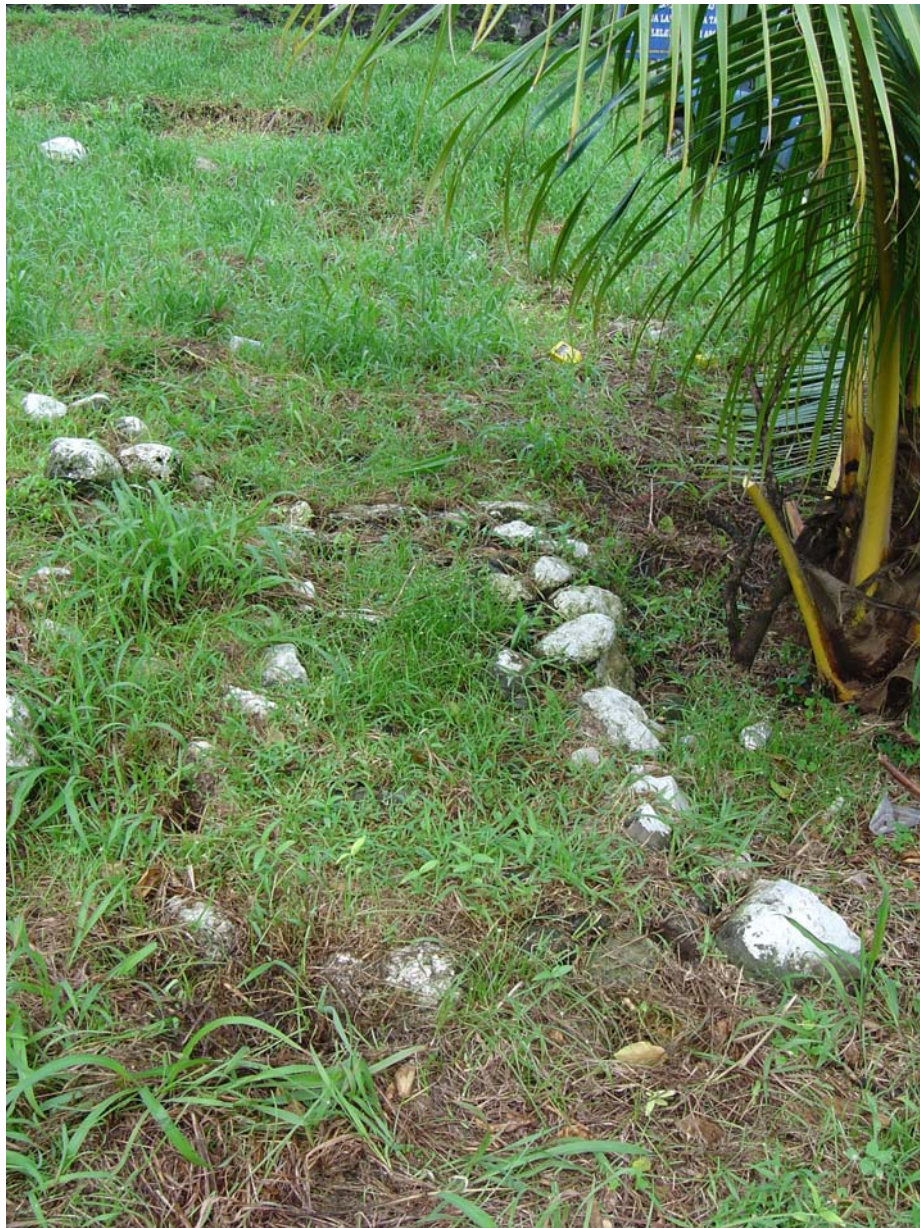
PHOTO:

EXISTING CONDITION	CONSERVATION STRATEGY
<p>POSITION: fallen unstable overgrown tilted marker/ base other <u>sunken core</u></p> <p>DETERIORATION: ----- broken cracked losses flaking/sugaring delaminations/detachment other _____</p> <p>SOILING: biological general graffiti efflorescence painting other</p> <p>FAILED TREATMENTS: ----- metal adhesives/coatings mortar other _____</p>	<p>POSITION: reset in ground reset to existing base resquare botom edge remove fragments in setting slot construct new base possible new base required stabilize foundation</p> <p>DETERIORATION: structural adhesion repair mortars crack fillers flowable grouts consolidation</p> <p>SOILING: chemical pressure wash poultice air abrasion</p> <p>FAILED TREATMENTS: drill/grind hand tools solvents air abrasion</p>

SUMMARY: Overgrown basalt rock outline with corefill; outline painted white.

ongoing deterioration/treatment required 2-5 years **re-inspect in 5 years**
