CEMETERY SURVEY FORM

SITE NAME: Satala Naval Cemetery

LOCATION: Maoputasi County, Tutuila Island, American Samoa

PLOT IDENTIFICATION: 61E

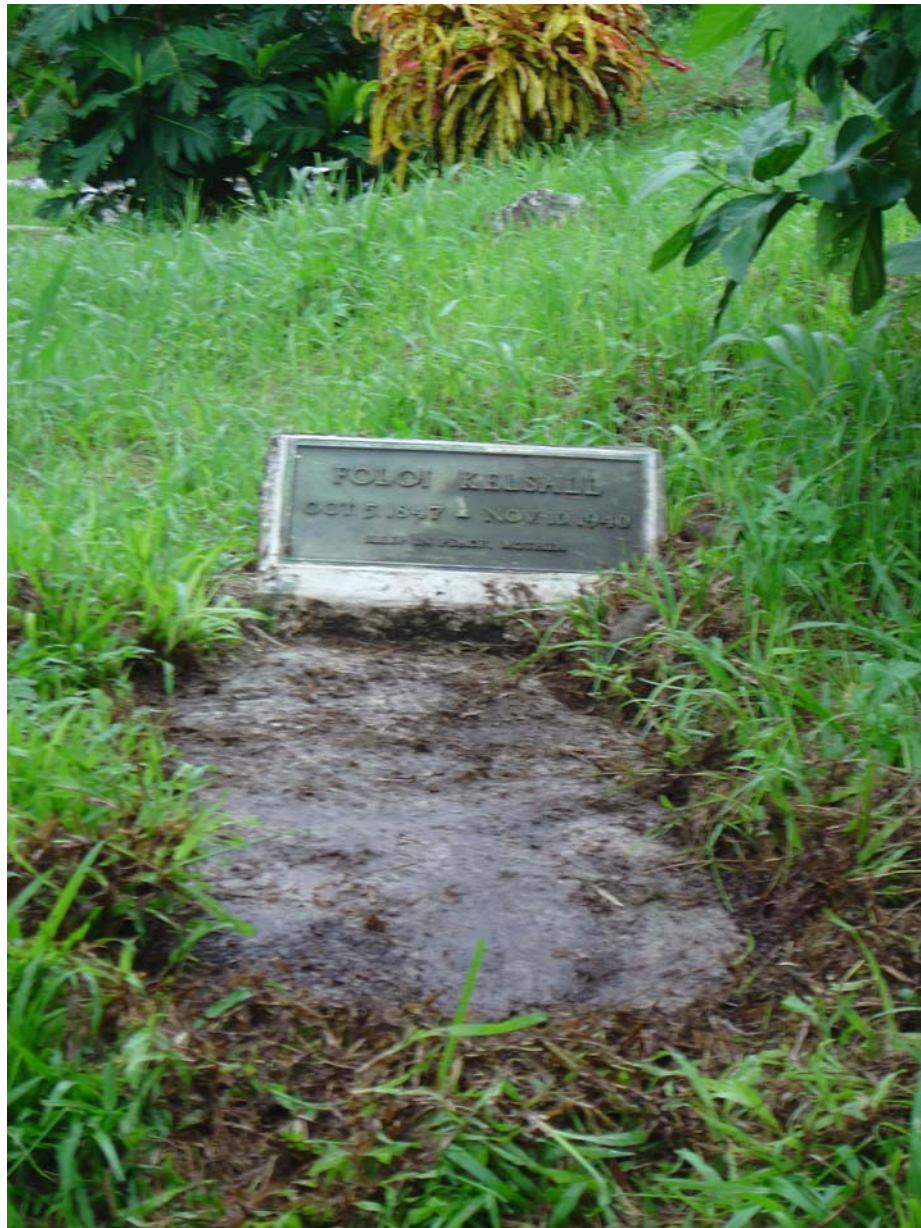
PHOTO:

SUMMARY: Overgrown; marker covered in flaking white paint and mildew. Plaque is tarnished.

ongoing deterioration/treatment required 2-5 years **re-inspect in 5 years**
