CEMETERY SURVEY FORM

SITE NAME: Satala Naval Cemetery

PLOT IDENTIFICATION: 61G

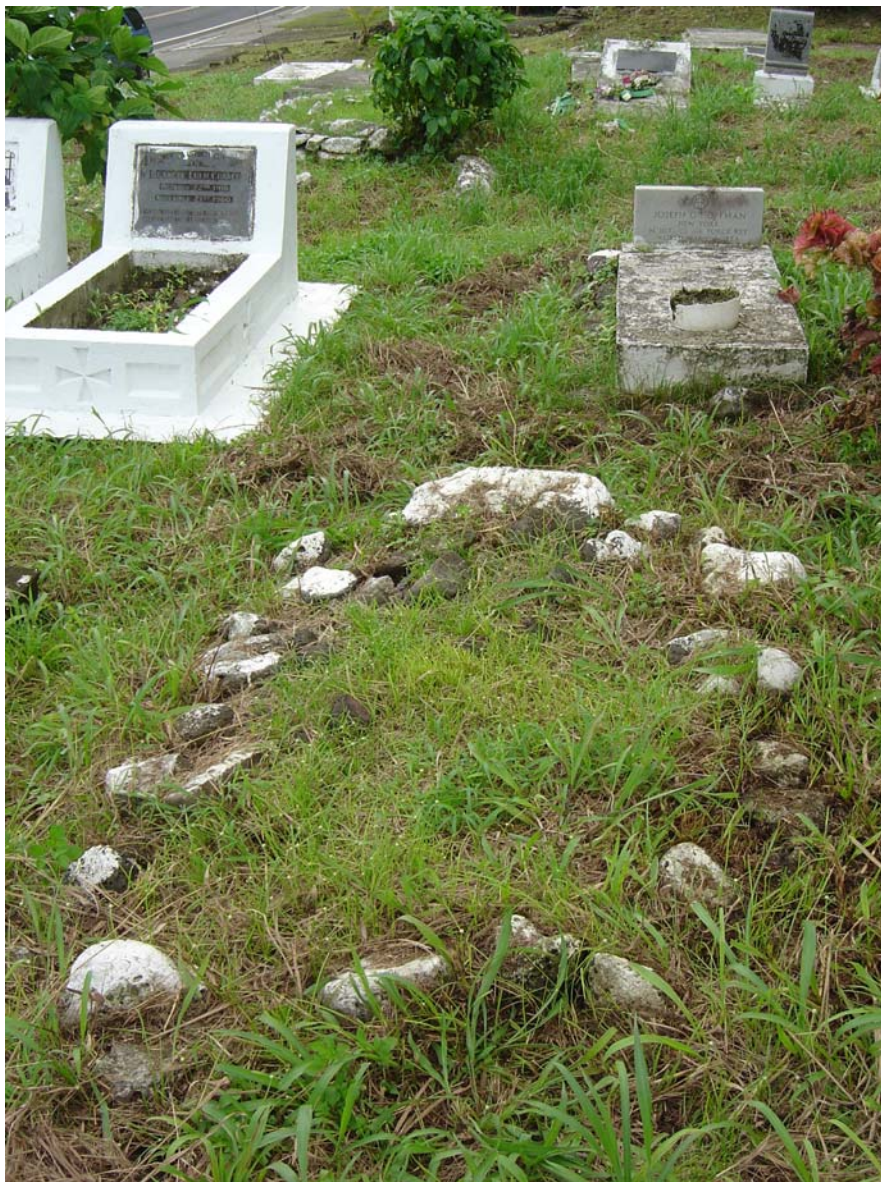
PHOTO:

SUMMARY: Overgrown with vegetation; curb outline marked by white paint. Large rock at W end may be marker

hazardous/immediate action **unstable deterioration/ASAP**
