# CEMETERY SURVEY FORM

SITE NAME: Satala Naval Cemetery

PLOT IDENTIFICATION: 63

NAME(S) OF INTERRED: HENRY N. BRIGGS

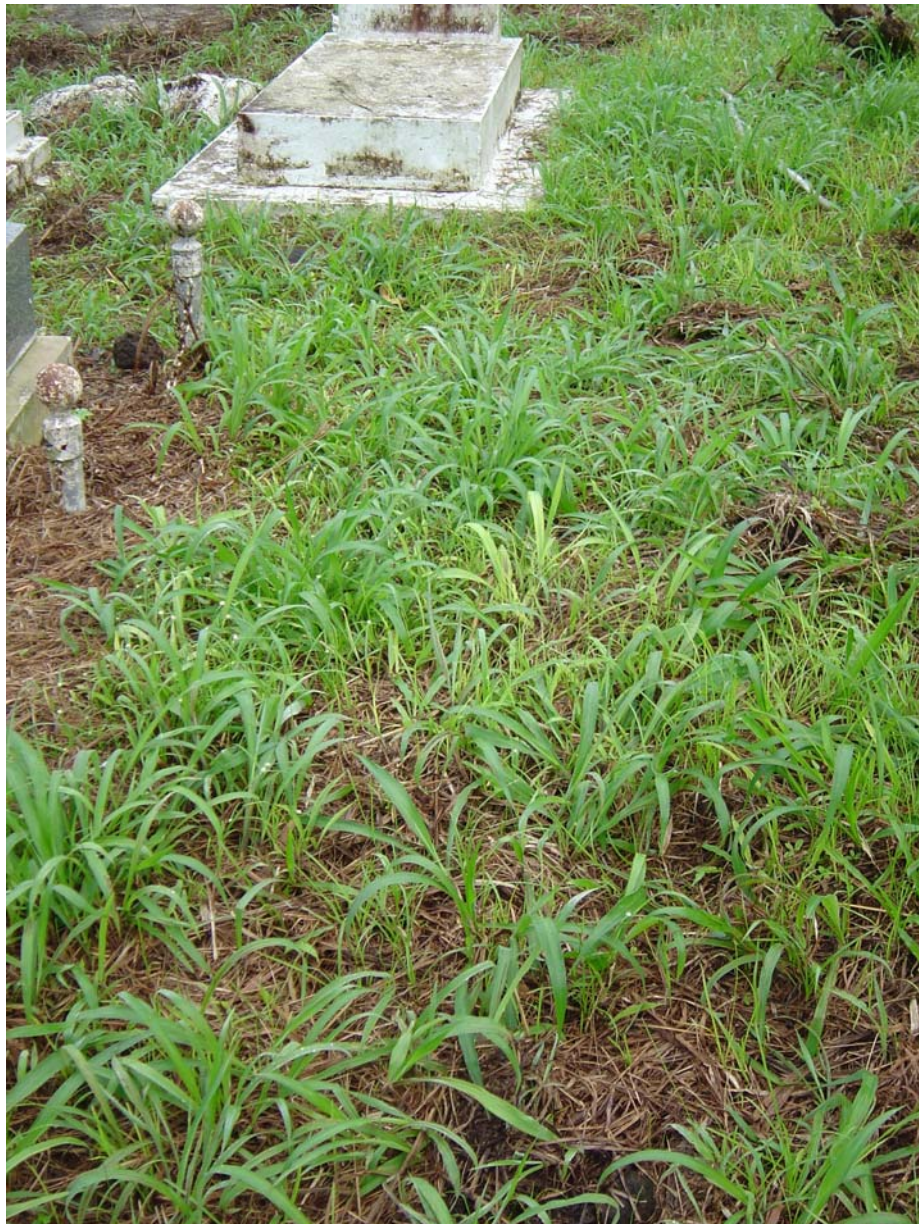
PHOTO:

EXISTING CONDITION	CONSERVATION STRATEGY
<p>POSITION: fallen unstable <b>overgrown</b> tilted marker/ base other _____</p> <p>DETERIORATION: mable to tell broken cracked losses flaking/sugaring delaminations/detachment other _____</p> <p>SOILING: ----- biological general graffiti efflorescence painting other</p> <p>FAILED TREATMENTS: ----- metal adhesives/coatings mortar other _____</p>	<p>POSITION: reset in ground reset to existing base resquare botom edge remove fragments in setting slot construct new base possible new base required stabilize foundation</p> <p>DETERIORATION: structural adhesion repair mortars crack fillers flowable grouts consolidation</p> <p>SOILING: chemical pressure wash poultice air abrasion</p> <p>FAILED TREATMENTS: drill/grind hand tools solvents air abrasion</p>

hazardous/immediate action **unstable deterioration/ASAP**

SUMMARY: Unable to tell nature of grave possibly overgrown, originally mapped as earthen mound.
