CEMETERY SURVEY FORM

SITE NAME: Satala Naval Cemetery

PLOT IDENTIFICATION: 73

TOMINAGA

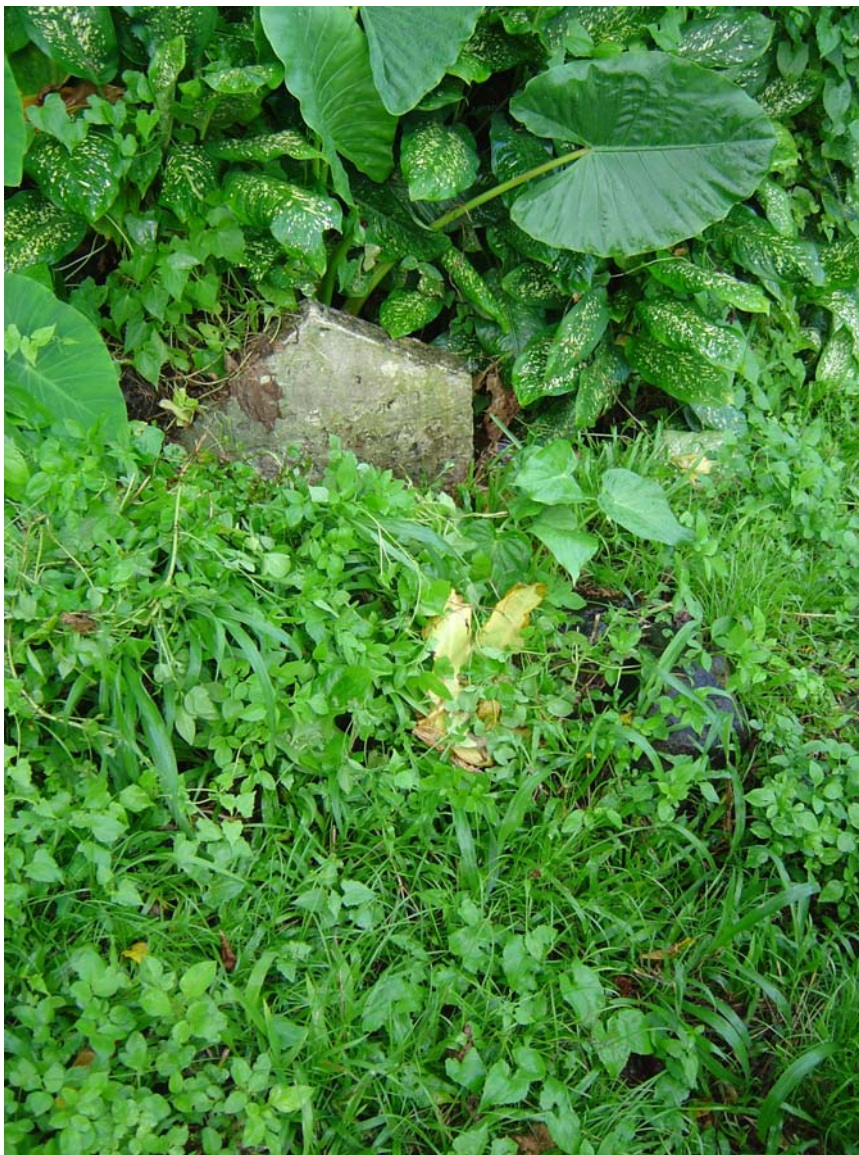
PHOTO:

TYPE OF PRIMARY STRUCTURE (portion containing inscription): Only one rock visible,
grave covered by plumeric trunk and other vegetation.

Washed out in 2003 flood, lg. rocks of outline still in place but partially buried in vegetation and debris. Headstone illegible from paint and mildew.
