CEMETERY SURVEY FORM

SITE NAME: Satala Naval Cemetery

LOCATION: Maoputasi County, Tutuila Island, American Samoa

PLOT IDENTIFICATION: 8

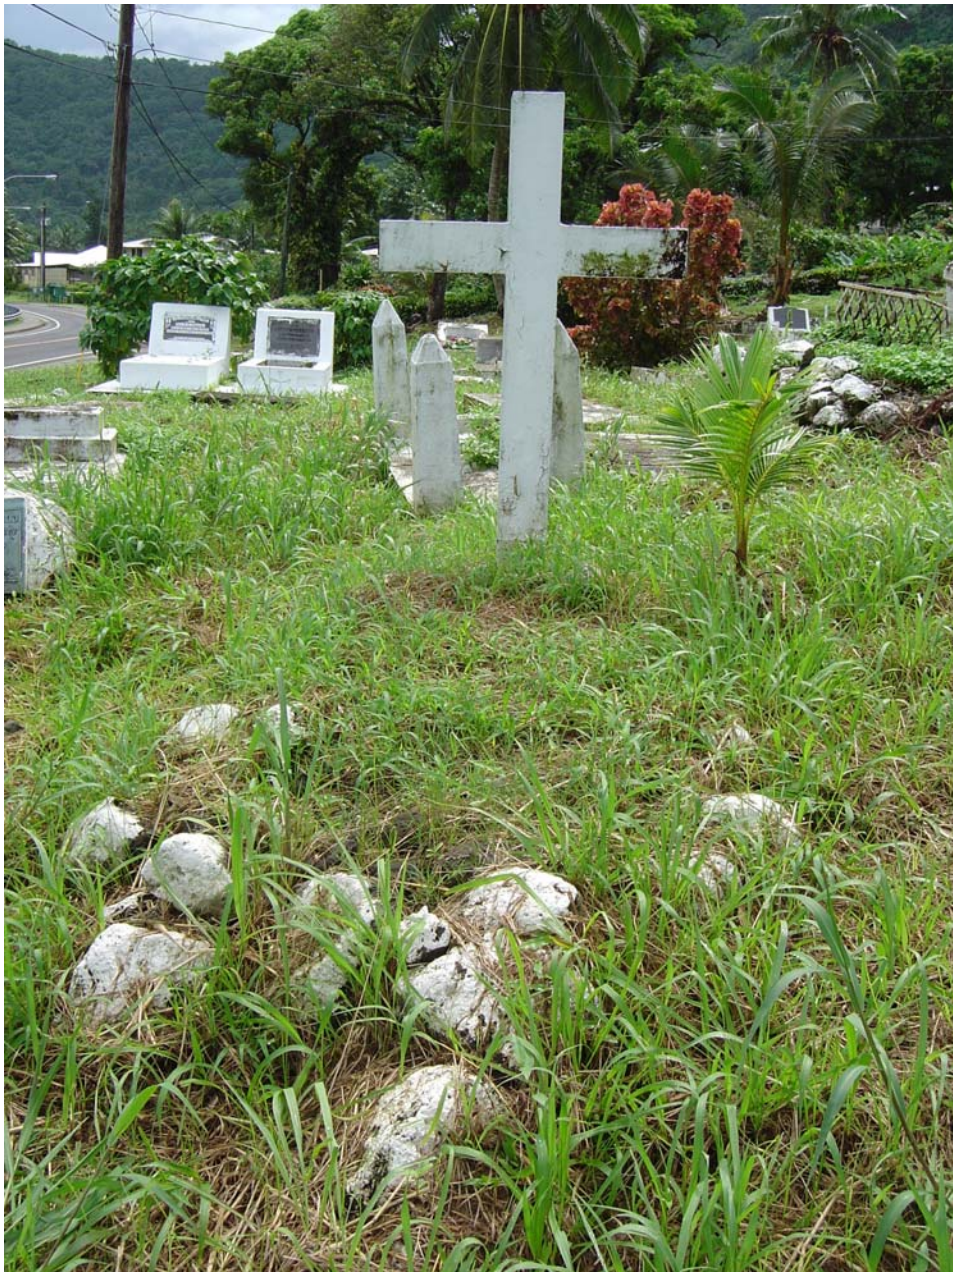
PHOTO:

EXISTING CONDITION	CONSERVATION STRATEGY
<p>POSITION: fallen unstable overgrown tilted marker/ base other _____</p> <p>DETERIORATION: ----- broken cracked losses flaking/sugaring delaminations/detachment other _____</p> <p>SOILING: biological general graffiti efflorescence painting other</p> <p>FAILED TREATMENTS: ----- metal adhesives/coatings mortar other _____</p>	<p>POSITION: reset in ground reset to existing base resquare botom edge remove fragments in setting slot construct new base possible new base required stabilize foundation</p> <p>DETERIORATION: structural adhesion repair mortars crack fillers flowable grouts consolidation</p> <p>SOILING: chemical pressure wash poultice air abrasion</p> <p>FAILED TREATMENTS: drill/grind hand tools solvents air abrasion</p>

ongoing deterioration/treatment required 2-5 years **re-inspect in 5 years**

SUMMARY: Rocks and cross need to be cleaned of vegetation, paint and mildew.
