CEMETERY SURVEY FORM

SITE NAME: Satala Naval Cemetery

LOCATION: Maoputasi County, Tutuila Island, American Samoa

PLOT IDENTIFICATION: 80

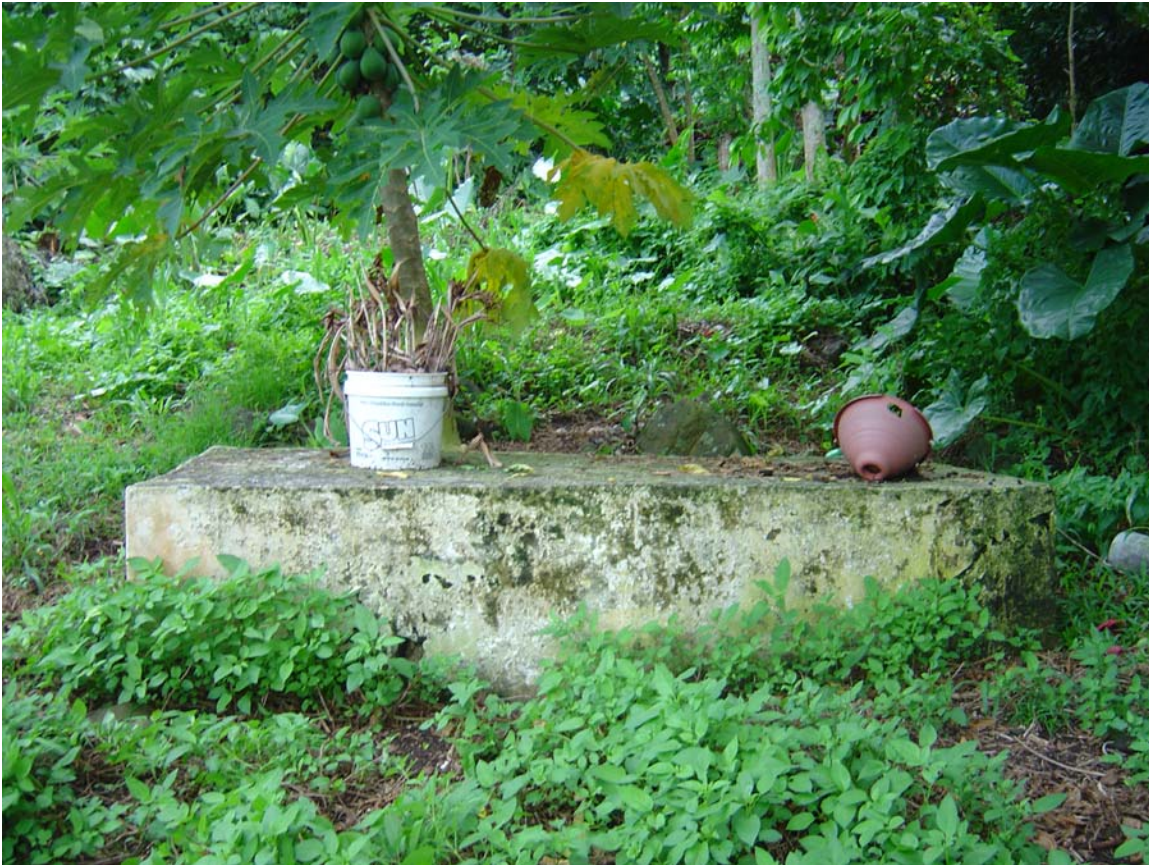
PHOTO:

TYPE OF PRIMARY STRUCTURE (portion containing inscription): Only one rock visible, grave covered by plumeric trunk and other vegetation.

EXISTING CONDITION	CONSERVATION STRATEGY
<p>POSITION: fallen unstable overgrown tilted marker/ base other <u>-partially buried?</u></p> <p>DETERIORATION: broken cracked losses flaking/sugaring delaminations/detachment other _____</p> <p>SOILING: biological general graffiti efflorescence painting other</p> <p>FAILED TREATMENTS: -- metal adhesives/coatings mortar other _____</p>	<p>POSITION: reset in ground reset to existing base resquare botom edge remove fragments in setting slot construct new base possible new base required stabilize foundation</p> <p>DETERIORATION: structural adhesion repair mortars crack fillers flowable grouts consolidation</p> <p>SOILING: chemical pressure wash poultice air abrasion</p> <p>FAILED TREATMENTS: drill/grind hand tools solvents air abrasion</p>

Surface of Concrete Flaking; remnants of white paint also visible.
