CEMETERY SURVEY FORM

SITE NAME: Satala Naval Cemetery

PLOT IDENTIFICATION: 88

NAME(S) OF INTERRED: Chi Bu Ouk

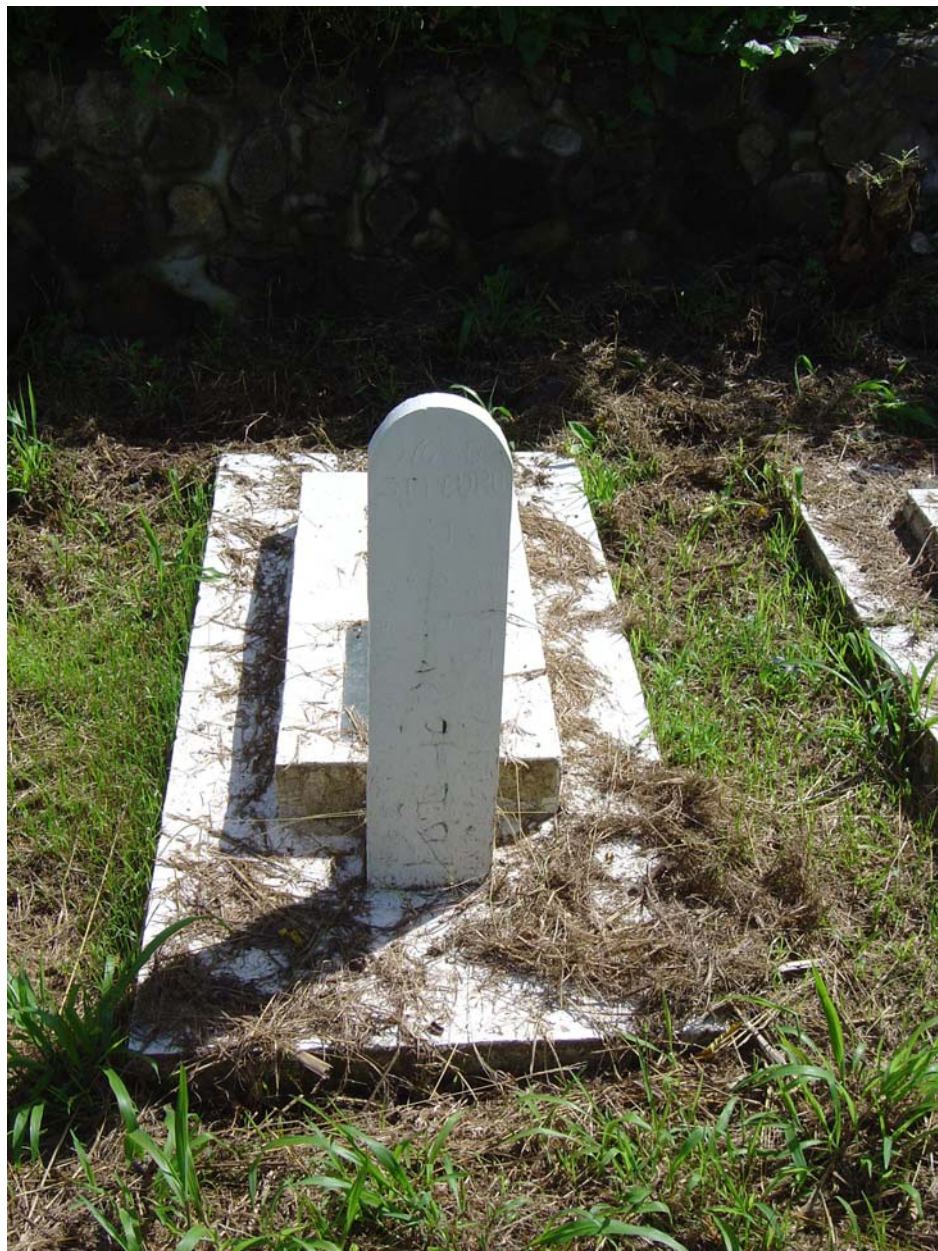
PHOTO:

SUMMARY: Grave is maintained by the American Samoa Korean Association.

Surrounding vegetation overgrown occasionally. Cracked primary structure and base.
