CEMETERY SURVEY FORM

SITE NAME: Satala Naval Cemetery

PLOT IDENTIFICATION: 89

NAME(S) OF INTERRED: Sung Chan Lee

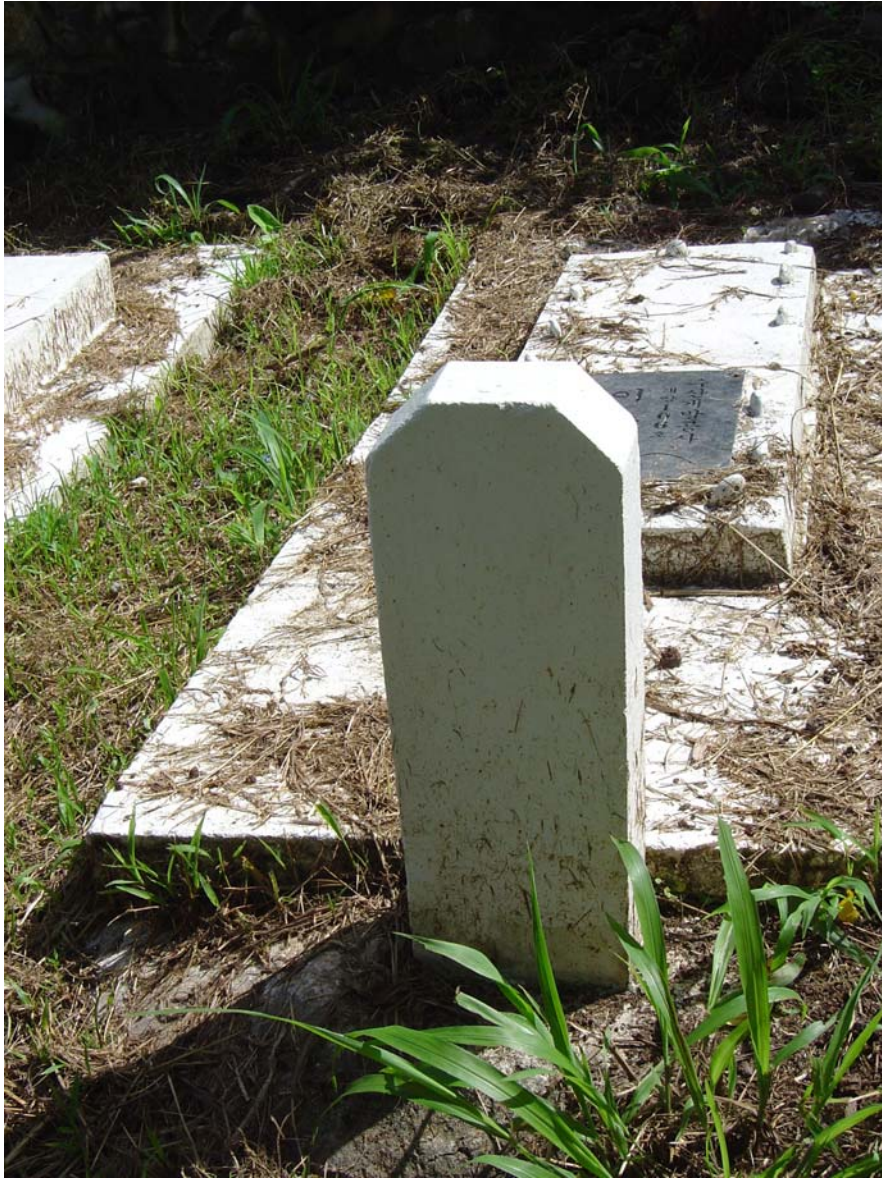
PHOTO:

SUMMARY: Grave is maintained by the American Samoa Korean Association.
Surrounding vegetation overgrown occasionally. No repairs needed.
