CEMETERY SURVEY FORM

SITE NAME: Satala Naval Cemetery LOCATION: Maoputasi County, Tutuila Island, American Samoa VILLAGE: Satala UTM COORDINATES: 02 533060mE 8421764mN OWNER: CONTACT: PHONE: SURVEYOR: Erika C. Radewagen, M.A. DATE: 21 JAN 2005 WEATHER (circle all that apply): hot warm cool dry humid sunny rain overcast windy **IDENTIFICATION** PLOT IDENTIFICATION: 9 NAME(S) OF INTERRED: WILLIAM P. COLEMAN **BURTON COLEMAN** EARLIEST/FIRST BURIAL DATE: JUNE 1 1921 MOST RECENT/LAST BURIAL DATE: INSCRIPTION: -----CONDITION OF INSCRIPTION (circle one): mint clear but worn

SURVEYOR: E. Radewagen DATE: 21 JAN 2005 PLOT: 9

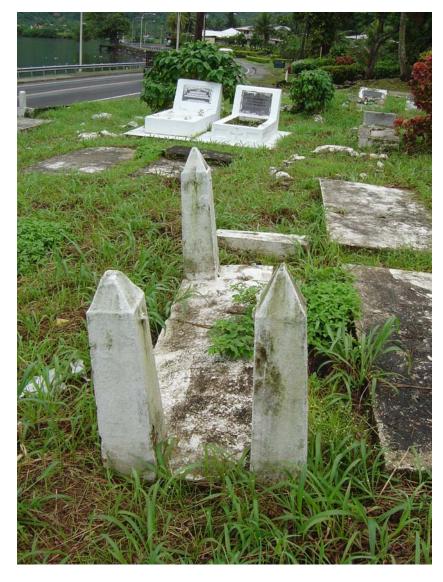
PHOTO:

SUMMARY: Concrete slab and three standing obelisk posts; missing chains, fallen obelisk visible; thick white paint and mildew on entire tomb; tilting/sinking down-slope S side.
