# CEMETERY SURVEY FORM

SITE NAME: Satala Naval Cemetery (AS-25-055)

PLOT IDENTIFICATION: 91

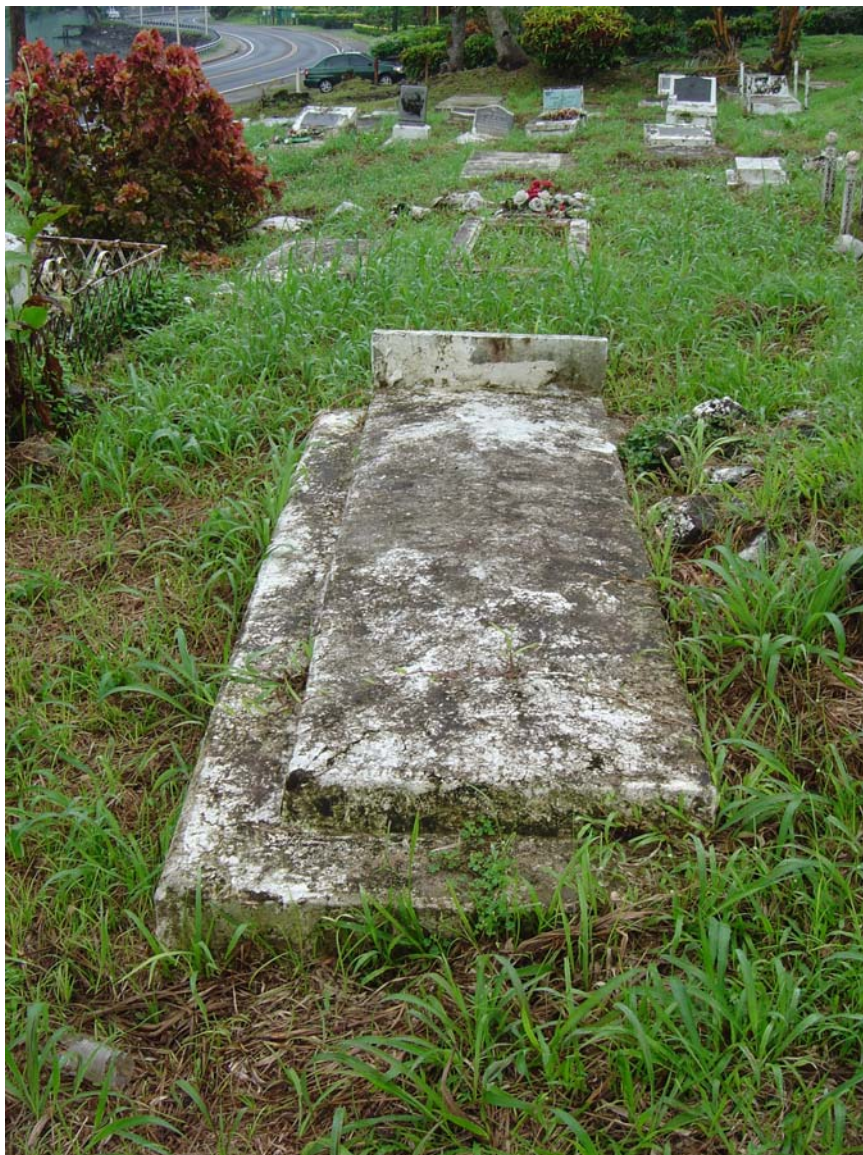
PHOTO:

EXISTING CONDITION	CONSERVATION STRATEGY
<p>POSITION: fallen unstable <b>overgrown</b> tilted marker/ base other _____</p> <p>DETERIORATION: broken <b>cracked</b> losses flaking/sugaring delaminations/detachment other _____</p> <p>SOILING: <b>biological</b> general graffiti efflorescence <b>painting</b> other</p> <p>FAILED TREATMENTS: ----- metal adhesives/coatings mortar other _____</p>	<p>POSITION: reset in ground reset to existing base resquare botom edge remove fragments in setting slot construct new base possible new base required stabilize foundation</p> <p>DETERIORATION: structural adhesion repair mortars crack fillers flowable grouts consolidation</p> <p>SOILING: chemical pressure wash poultice air abrasion</p> <p>FAILED TREATMENTS: drill/grind hand tools solvents air abrasion</p>

SUMMARY: 2 tier with possible headstone base intact; covered in thick white paint and mildew; cracks in primary structure on E side.

hazardous/immediate action **unstable deterioration/ASAP**
