CEMETERY SURVEY FORM

SITE NAME: Satala Naval Cemetery (AS-25-055)

PLOT IDENTIFICATION: 93

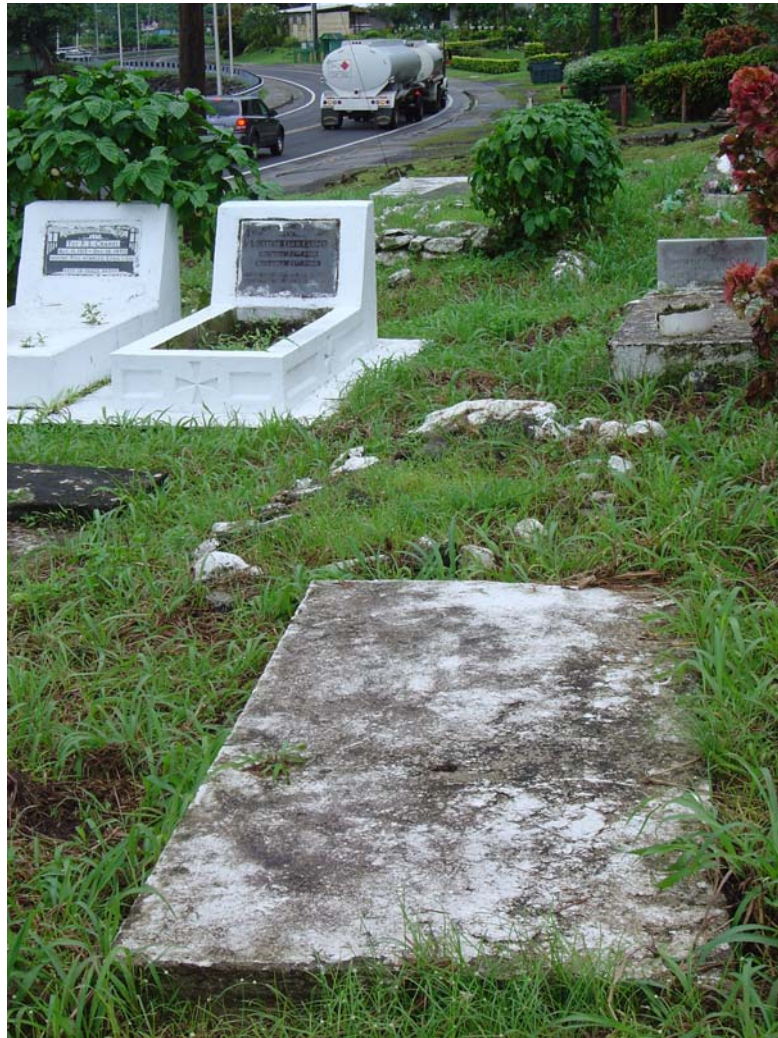
PHOTO:

SUMMARY: The concrete slab is covered in layers of thick white paint and the painted surface has mildew patches. Some sugaring of concrete occurring in exposed areas. Mildew should be washed off and painted should be removed. Sugaring needs to be stabilized in exposed areas.
