CEMETERY SURVEY FORM

SITE NAME: Satala Naval Cemetery (AS-25-055)

LOCATION: Maoputasi County, Tutuila Island, American Samoa

PLOT IDENTIFICATION: 95

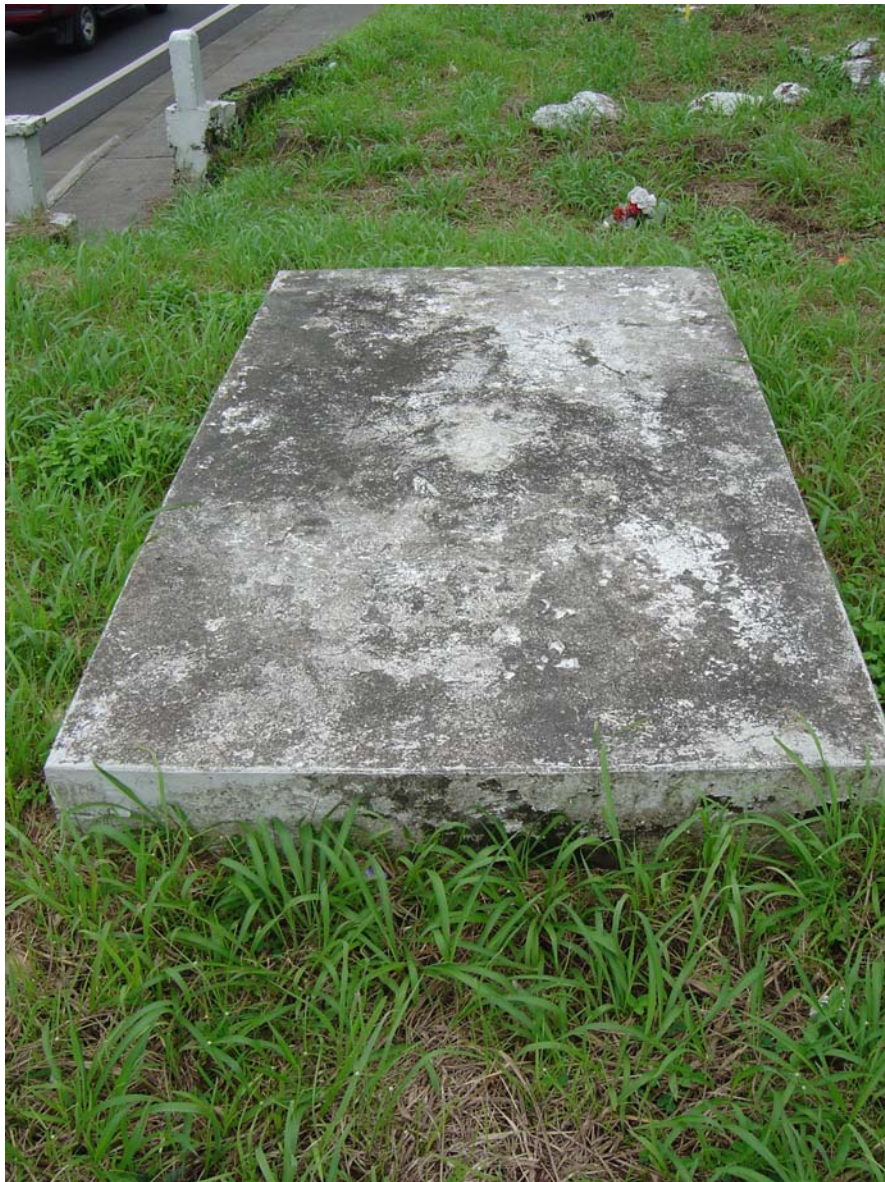
PHOTO:

SUMMARY: The concrete slab is covered in peeling, flaking layers of thick white paint. Paint should be removed.
