CEMETERY SURVEY FORM

SITE NAME: Satala Naval Cemetery (AS-25-055)

DATE: 20 January 2005

PLOT IDENTIFICATION: 96

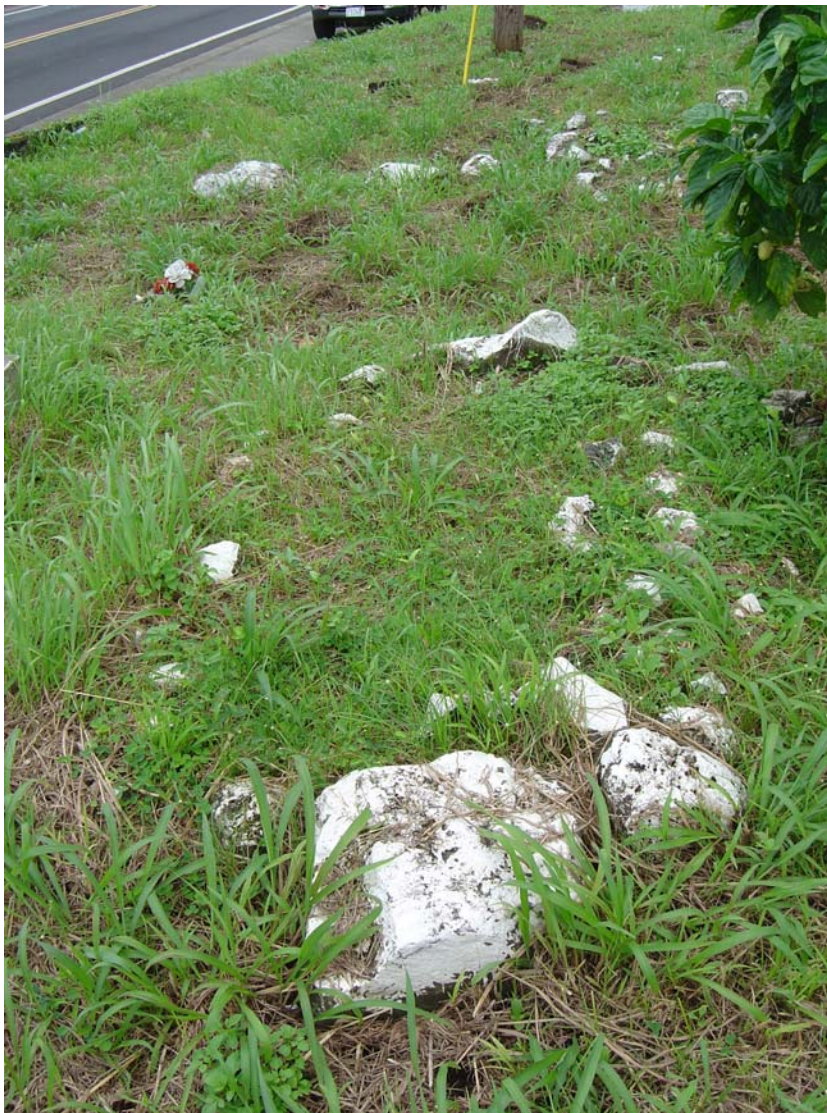
PHOTO:

SUMMARY: The primary structure consists of a basalt rock oval outline with basalt paving. The grave is covered in white paint and weeds. Paint and weeds should be removed.

ongoing deterioration/treatment required 2-5 years **re-inspect in 5 years**
