CEMETERY SURVEY FORM

SITE NAME: Satala Naval Cemetery (AS-25-055)

PLOT IDENTIFICATION: 99

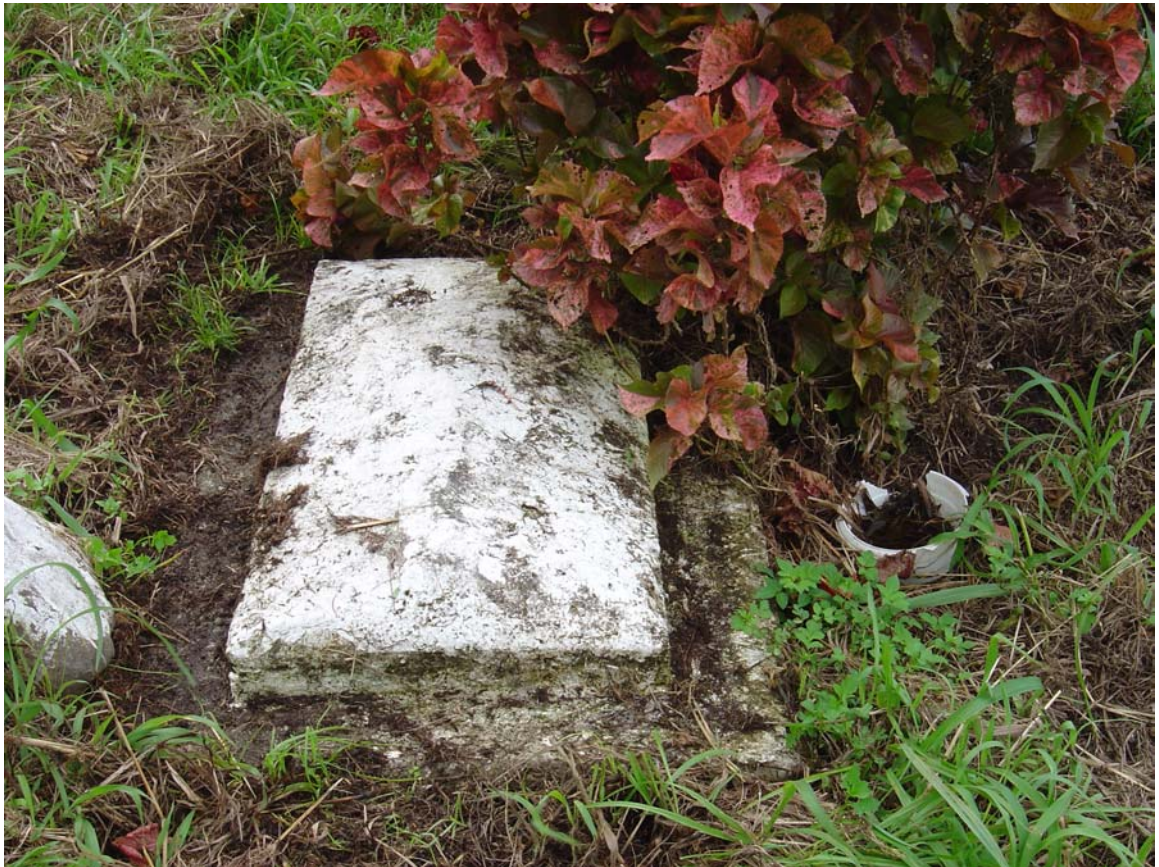
PHOTO:

SUMMARY: The entire grave is covered in layers of thick, flaking, and peeling white paint and mildew. Paint and mildew should be removed.
