CEMETERY SURVEY FORM

SITE NAME: Satala Naval Cemetery

LOCATION: Maoputasi County, Tutuila Island, American Samoa

PLOT IDENTIFICATION: FEATURE 1

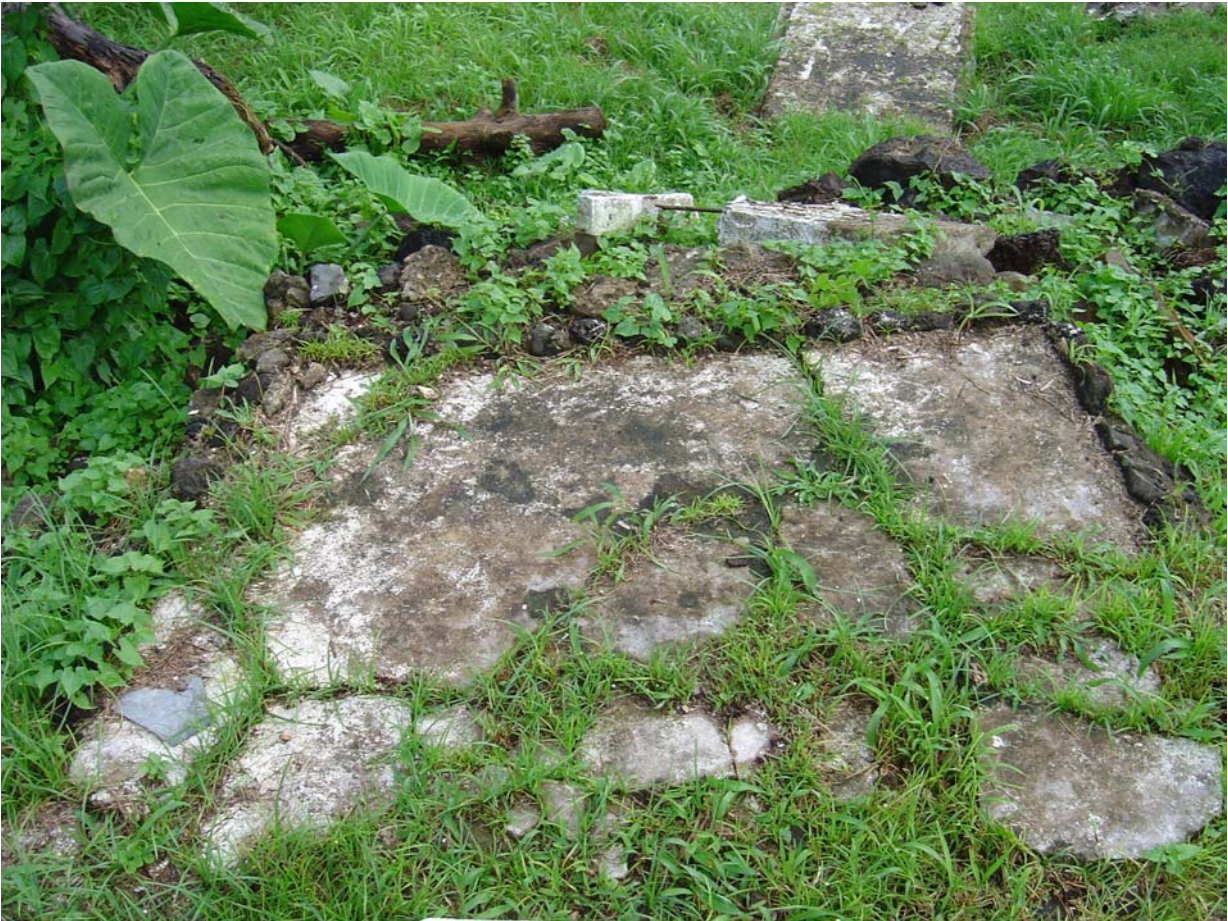
PHOTO:

SUMMARY: The primary structure has large cracks and broken . The grave marker does not belong to the feature. It is unlikely that this is a grave. The south side is eroding
Paint, vegetation and mildew need to be removed.
