CEMETERY SURVEY FORM

SITE NAME: Satala Naval Cemetery (AS-25-055)

PLOT IDENTIFICATION: 103

NAME(S) OF INTERRED: Keith Gordon-Wylie

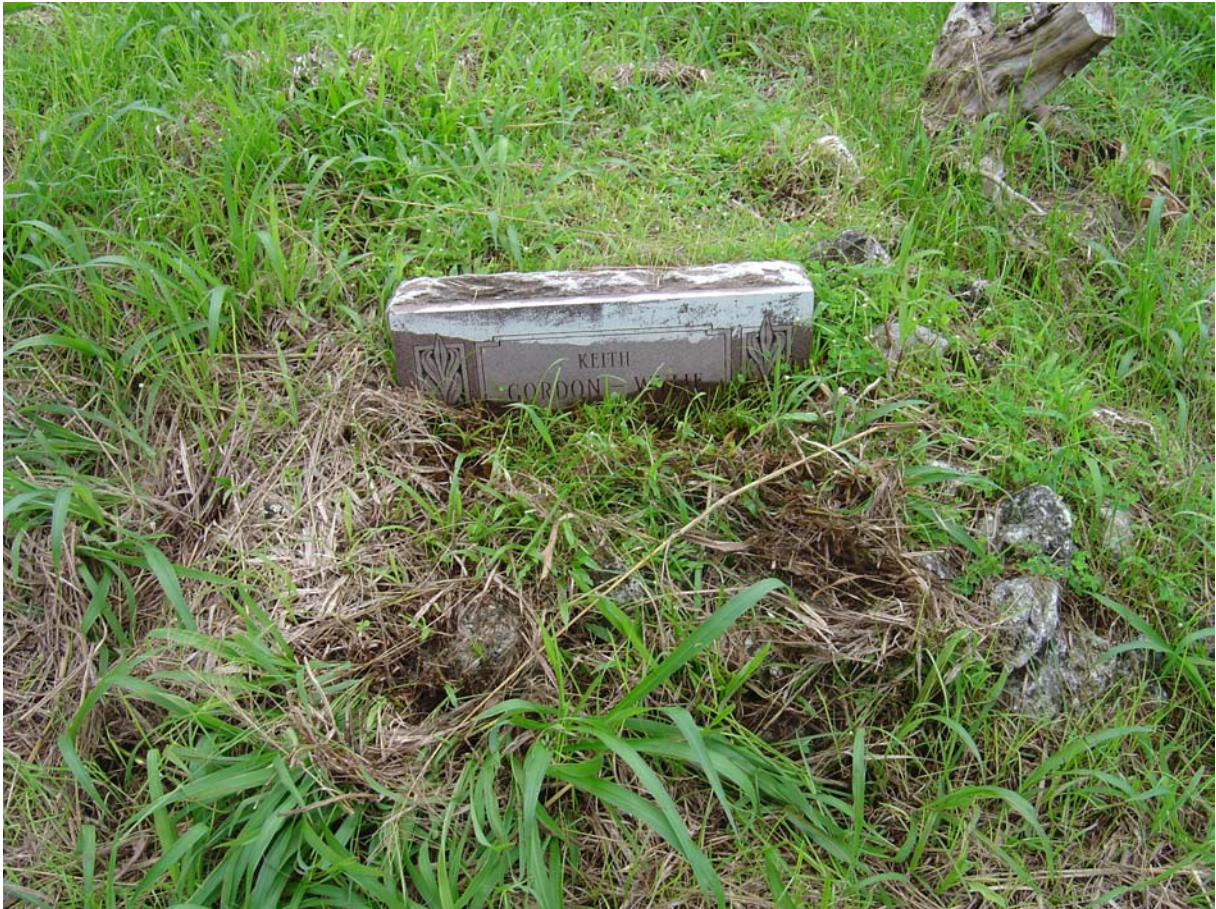
PHOTO:

SUMMARY: The grave is covered in layers of thick white paint and the painted surface has mildew patches. The headstone marker is buried within the rock mound and should be reset. Mildew should be washed off and paint should be removed.
