## CEMETERY SURVEY FORM

SITE NAME: Satala Naval Cemetery (AS-25-055)

PLOT IDENTIFICATION: 109

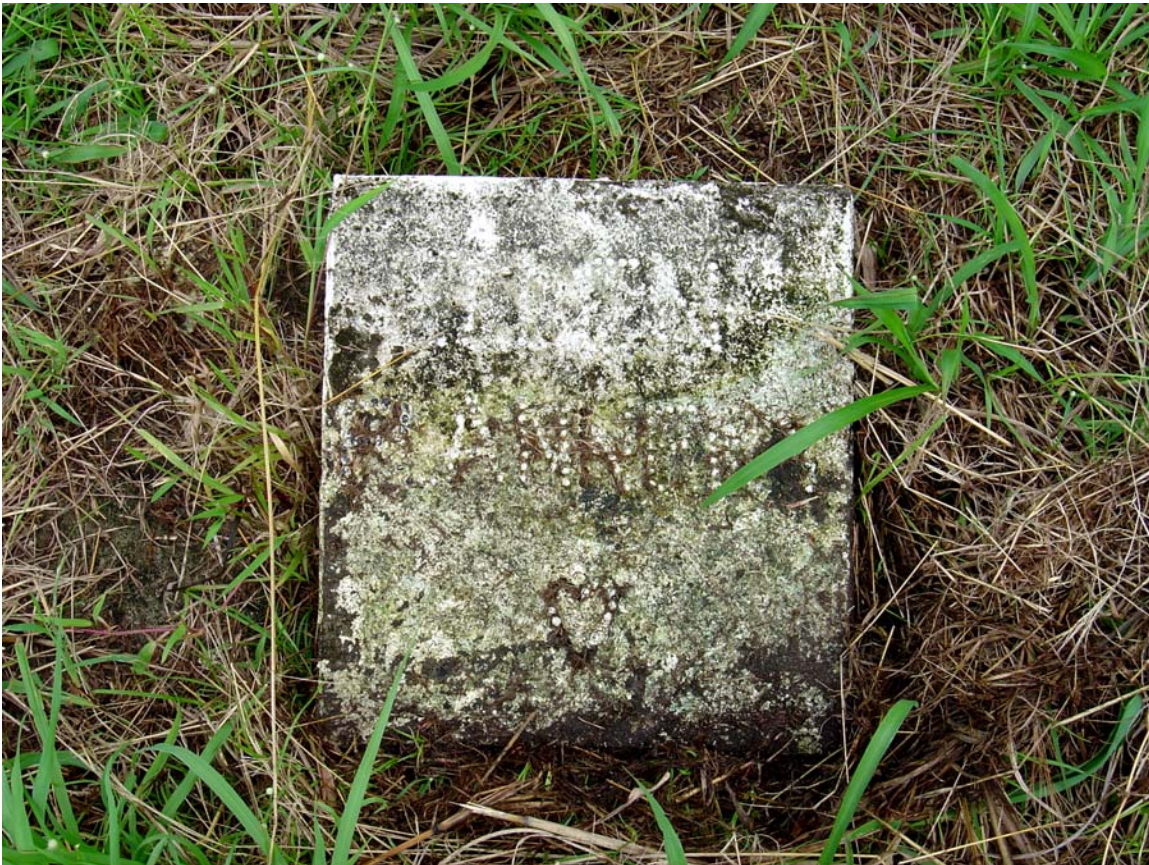
PHOTO:

EXISTING CONDITION	CONSERVATION STRATEGY
<p><b>POSITION:</b>                      fallen unstable <b>overgrown</b>                      tilted marker/ base <b>other (sunken)</b></p> <p><b>DETERIORATION:</b>                      broken cracked losses flaking/sugaring                      delaminations/detachment                      other _____</p> <p><b>SOILING:</b>  <b>biological</b> general graffiti efflorescence  <b>painting</b> other</p> <p><b>FAILED TREATMENTS:</b>                      metal adhesives/coatings mortar                      other _____</p>	<p><b>POSITION:</b>                      reset in ground                      reset to existing base                      resquare botom edge                      remove fragments in setting slot                      construct new base                      possible new base required                      stabilize foundation</p> <p><b>DETERIORATION:</b>                      structural adhesion repair mortars                      crack fillers flowable grouts                      consolidation</p> <p><b>SOILING:</b>                      chemical pressure wash                      poultice air abrasion</p> <p><b>FAILED TREATMENTS:</b>                      drill/grind hand tools solvents                      air abrasion</p>

SUMMARY: The inscription consists of ball shot, some missing in the lettering. The small base slab may extend east in length although undetectable with probe. Covered with mildew and paint.
