CEMETERY SURVEY FORM

SITE NAME: Satala Naval Cemetery (AS-25-055)

PLOT IDENTIFICATION: 110

NAME(S) OF INTERRED: GEORGE E. FLANNERY

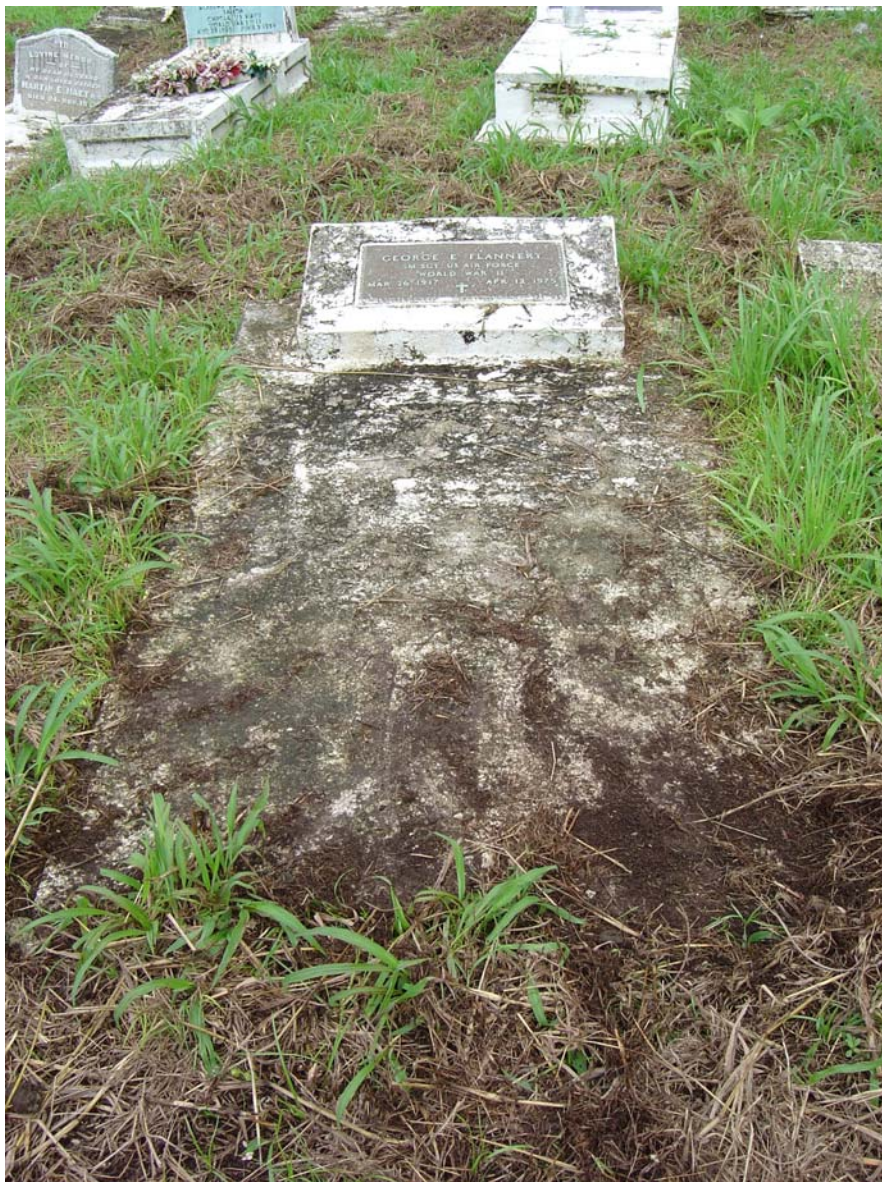
PHOTO:

SUMMARY: Flaking, peeling white paint with mildew on entire grave; flecks on plaque; tarnished green lettering; small broken corner of primary structure NE.
