# CEMETERY SURVEY FORM

SITE NAME: Satala Naval Cemetery (AS-25-055)

PLOT IDENTIFICATION: 128

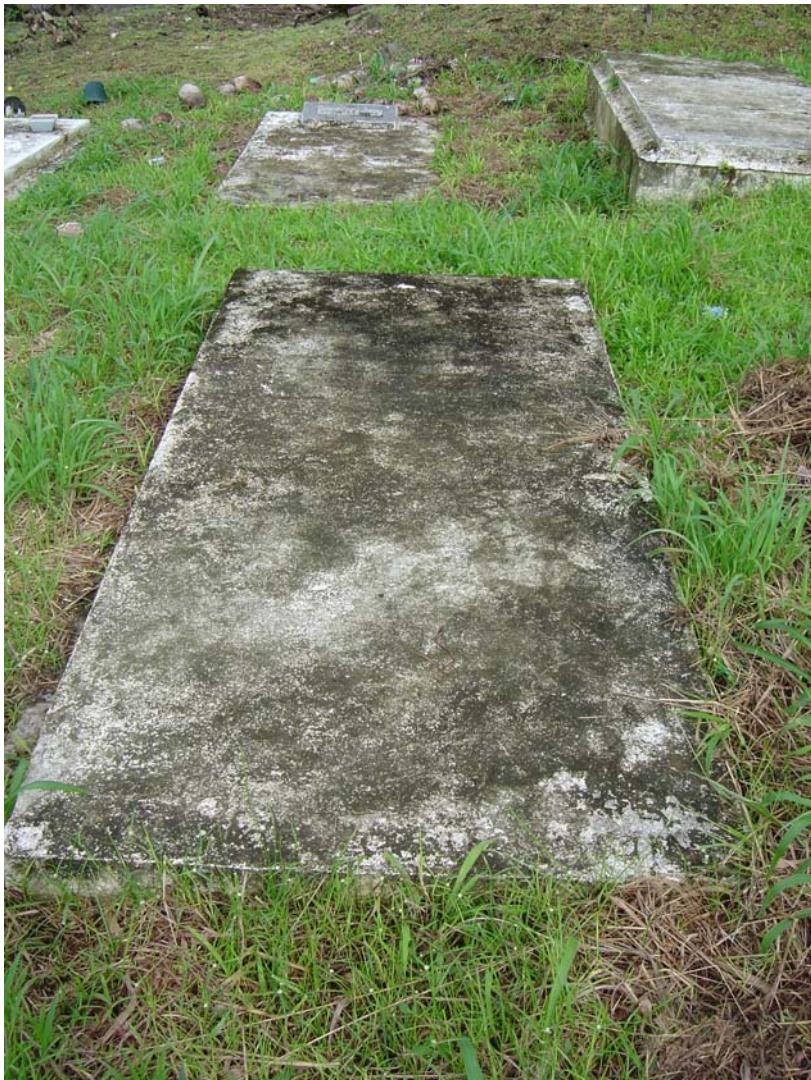
PHOTO:

Basalt rocks overgrown. Visible W and S edges.

EXISTING CONDITION	CONSERVATION STRATEGY
<p>POSITION: fallen unstable <b>overgrown</b> tilted marker/ base other _____</p> <p>DETERIORATION: broken cracked losses flaking/sugaring delaminations/detachment other <u>NONE</u></p> <p>SOILING: <b>biological</b> general graffiti efflorescence <b>painting</b> other</p> <p>FAILED TREATMENTS: metal adhesives/coatings mortar other <u>NONE</u></p>	<p>POSITION: reset in ground reset to existing base resquare botom edge remove fragments in setting slot construct new base possible new base required stabilize foundation</p> <p>DETERIORATION: structural adhesion repair mortars crack fillers flowable grouts consolidation</p> <p>SOILING: chemical pressure wash poultice air abrasion</p> <p>FAILED TREATMENTS: drill/grind hand tools solvents air abrasion</p>

SUMMARY: Base not visible along N edge; possible basalt rock enclosure visible along W edge and parts of the S edge; too overgrown; white paint flaking on primary structure.
