# CEMETERY SURVEY FORM

SITE NAME: Satala Naval Cemetery (AS-25-055)

PLOT IDENTIFICATION: 130

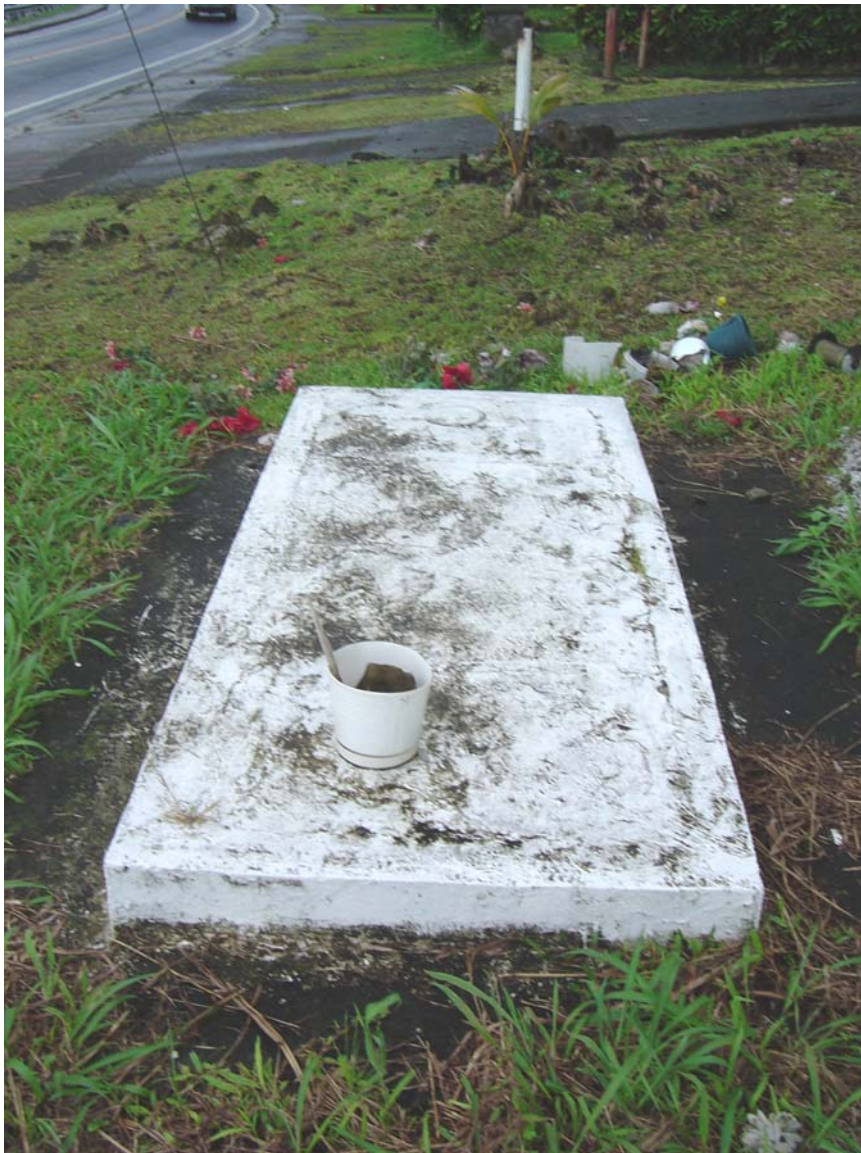
PHOTO:

EXISTING CONDITION	CONSERVATION STRATEGY
<p>POSITION: fallen unstable <b>overgrown</b> tilted marker/ base other _____</p> <p>DETERIORATION: N/A broken cracked losses flaking/sugaring delaminations/detachment other _____</p> <p>SOILING: <b>biological</b> general graffiti efflorescence <b>painting</b> other</p> <p>FAILED TREATMENTS: N/A metal adhesives/coatings mortar other _____</p>	<p>POSITION: N/A reset in ground reset to existing base resquare botom edge remove fragments in setting slot construct new base possible new base required stabilize foundation</p> <p>DETERIORATION: N/A structural adhesion repair mortars crack fillers flowable grouts consolidation</p> <p>SOILING: chemical <b>pressure wash</b> poultice air abrasion</p> <p>FAILED TREATMENTS: N/A drill/grind hand tools solvents air abrasion</p>

SUMMARY: Stable interment made of concrete; only visible concern is flaking white paint on primary structure; no inscription/marker to indicate burial date or person.

ongoing deterioration/treatment required 2-5 years    **re-inspect in 5 years**

**monitor**
