## CEMETERY SURVEY FORM

SITE NAME: Satala Naval Cemetery (AS-25-055)

PLOT IDENTIFICATION: 132

NAME(S) OF INTERRED: LAWRENCE R. MORAN

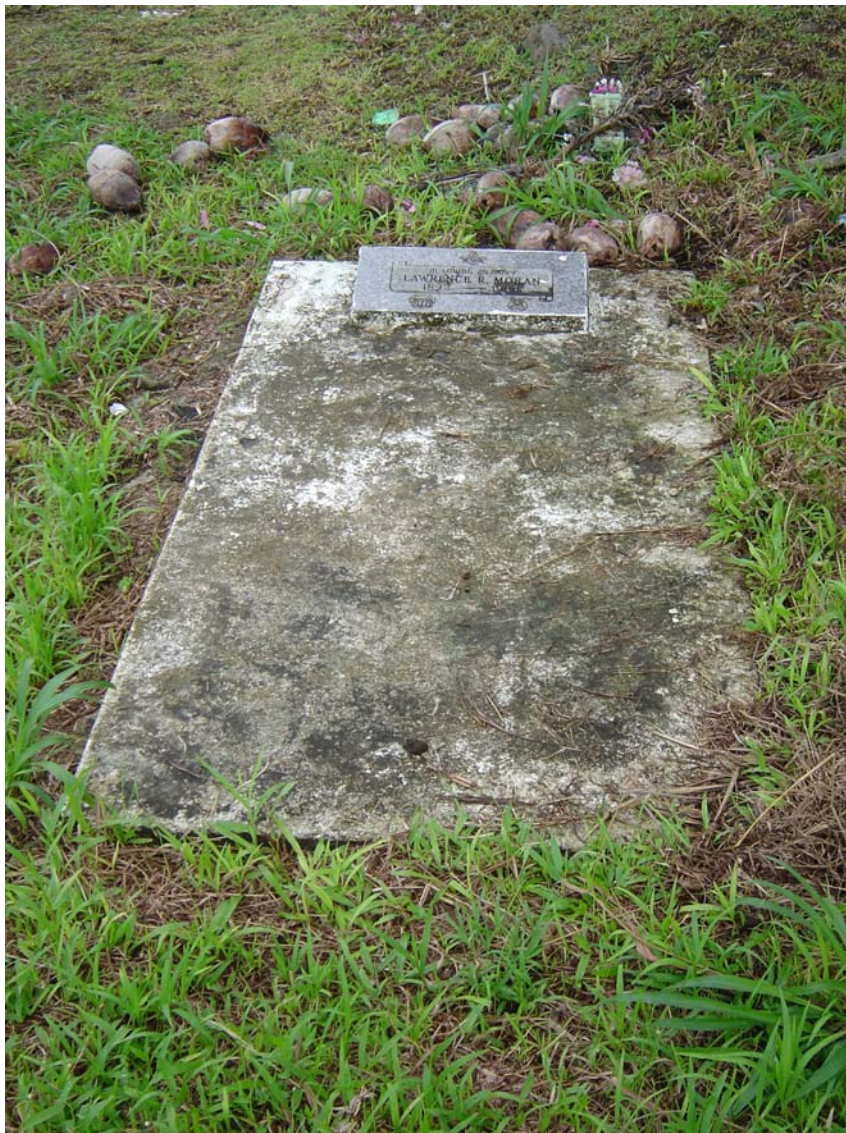
PHOTO:

SUMMARY: N and E edges of plot completely overgrown. Cannot find base outline. Interment is stable; only concern white paint on primary structure. 3 Masonic Order symbols by inscription : 2 headed eagle; saber with circled star and figurehead; square compass with G.

ongoing deterioration/treatment required 2-5 years    **re-inspect in 5 years**

**monitor**
