# CEMETERY SURVEY FORM

SITE NAME: Satala Naval Cemetery

LOCATION: Maoputasi County, Tutuila Island, American Samoa

PLOT IDENTIFICATION: 26

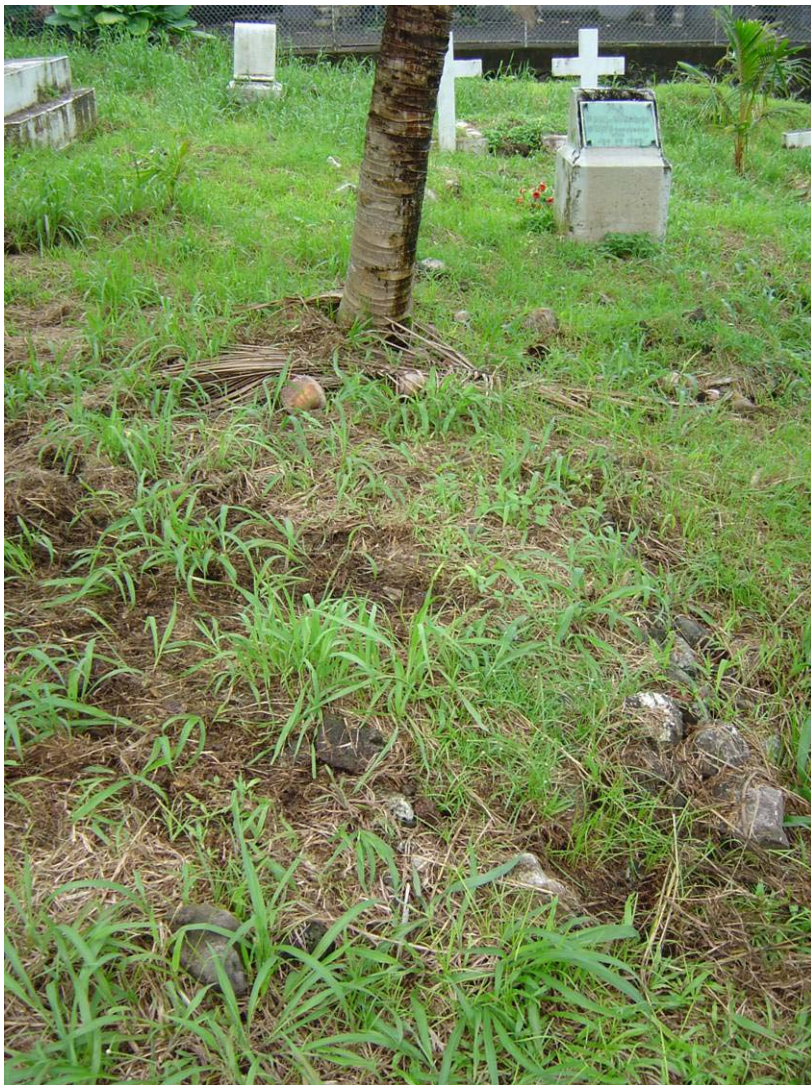
PHOTO:

EXISTING CONDITION	CONSERVATION STRATEGY
<p>POSITION:</p> <p>fallen <b>unstable</b> <b>overgrown</b></p> <p>tilted marker/ base other _____</p> <p>DETERIORATION: -----</p> <p>broken cracked losses flaking/sugaring delaminations/detachment other _____</p> <p>SOILING:</p> <p><b>biological</b> general graffiti efflorescence <b>painting</b> other</p> <p>FAILED TREATMENTS: -----</p> <p>metal adhesives/coatings mortar other _____</p>	<p>POSITION:</p> <p>reset in ground reset to existing base resquare botom edge remove fragments in setting slot construct new base possible new base required stabilize foundation</p> <p>DETERIORATION:</p> <p>structural adhesion repair mortars crack fillers flowable grouts consolidation</p> <p>SOILING:</p> <p>chemical pressure wash poultice air abrasion</p> <p>FAILED TREATMENTS:</p> <p>drill/grind hand tools solvents air abrasion</p>

SUMMARY: S edge of rock mound is intact; N half is buried. Coconut tree located just off E edge; rocks are overgrown and painted white.

hazardous/immediate action **unstable deterioration/ASAP**
