# CEMETERY SURVEY FORM

SITE NAME: Satala Naval Cemetery

LOCATION: Maoputasi County, Tutuila Island, American Samoa

PLOT IDENTIFICATION: 28

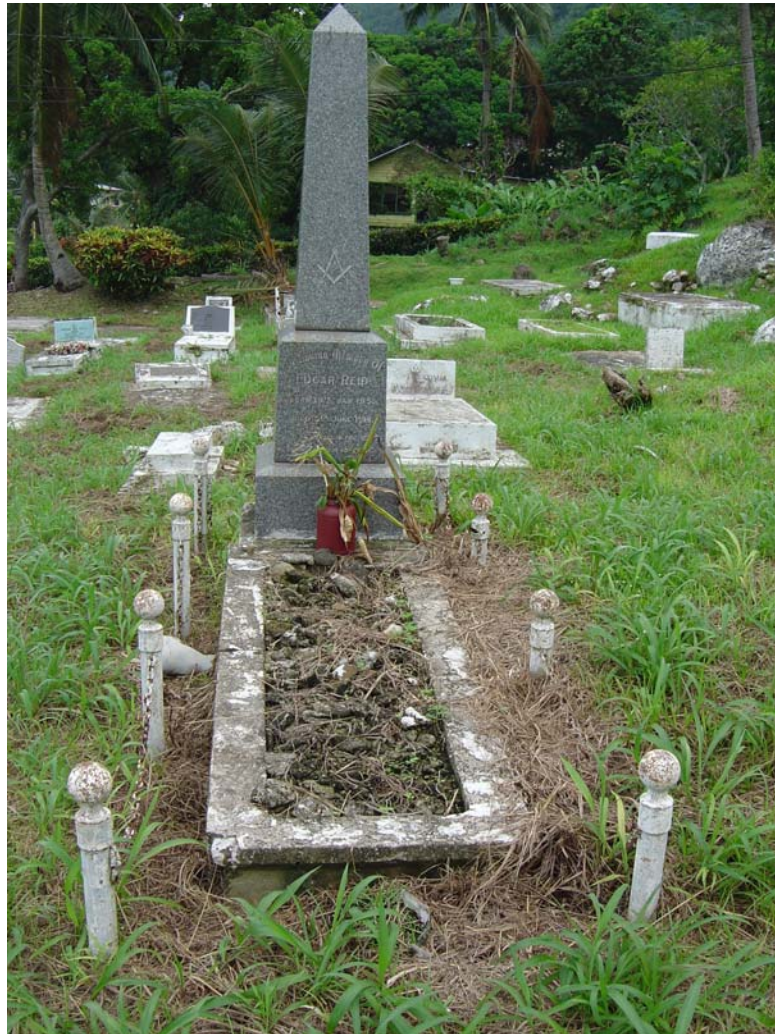
PHOTO:

SUMMARY: Open bedstead primary structure with obelisk pedestal headstone with engraved Masonic symbol; filled with coral pieces. Chain and posts rusting, chains missing between some posts. SE corner of bedstead broken, entire bedstead covered in flaking white paint, some concrete cracks with growing vegetation along top of bedstead.

**ongoing deterioration/treatment required 2-5 years**    re-inspect in 5 years
