# CEMETERY SURVEY FORM

SITE NAME: Satala Naval Cemetery

LOCATION: Maoputasi County, Tutuila Island, American Samoa

PLOT IDENTIFICATION: 32

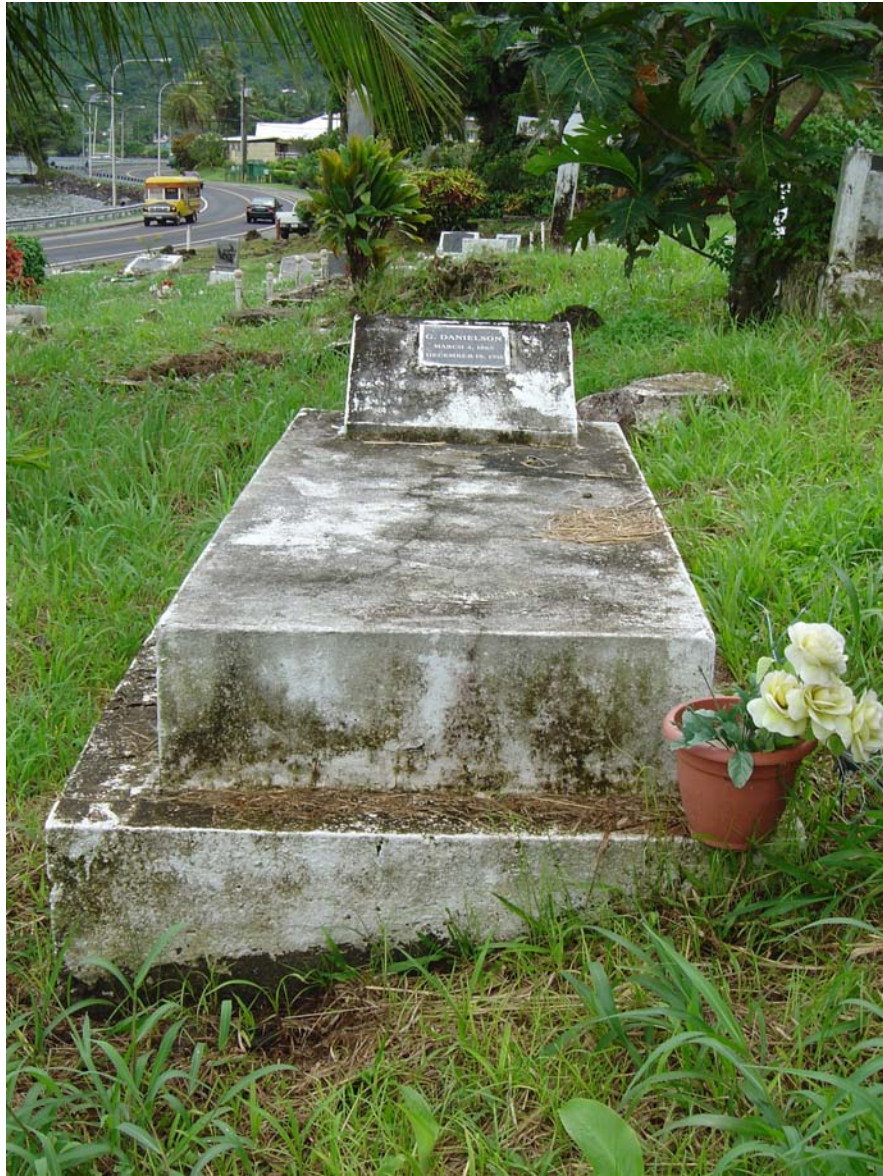
PHOTO:

EXISTING CONDITION	CONSERVATION STRATEGY
<p>POSITION: -----                      fallen unstable overgrown                      tilted marker/ base other _____</p> <p>DETERIORATION: -----                      broken cracked losses flaking/sugaring                      delaminations/detachment                      other _____</p> <p>SOILING:                      biological general graffiti efflorescence                      painting other</p> <p>FAILED TREATMENTS: -----                      metal adhesives/coatings mortar                      other _____</p>	<p>POSITION:                      reset in ground                      reset to existing base                      resquare botom edge                      remove fragments in setting slot                      construct new base                      possible new base required                      stabilize foundation</p> <p>DETERIORATION:                      structural adhesion repair mortars                      crack fillers flowable grouts                      consolidation</p> <p>SOILING:                      chemical pressure wash                      poultice air abrasion</p> <p>FAILED TREATMENTS:                      drill/grind hand tools solvents                      air abrasion</p>

SUMMARY: Needs to be cleaned of white paint and mildew.

ongoing deterioration/treatment required 2-5 years    **re-inspect in 5 years**
