# CEMETERY SURVEY FORM

SITE NAME: Satala Naval Cemetery

LOCATION: Maoputasi County, Tutuila Island, American Samoa

PLOT IDENTIFICATION: 39

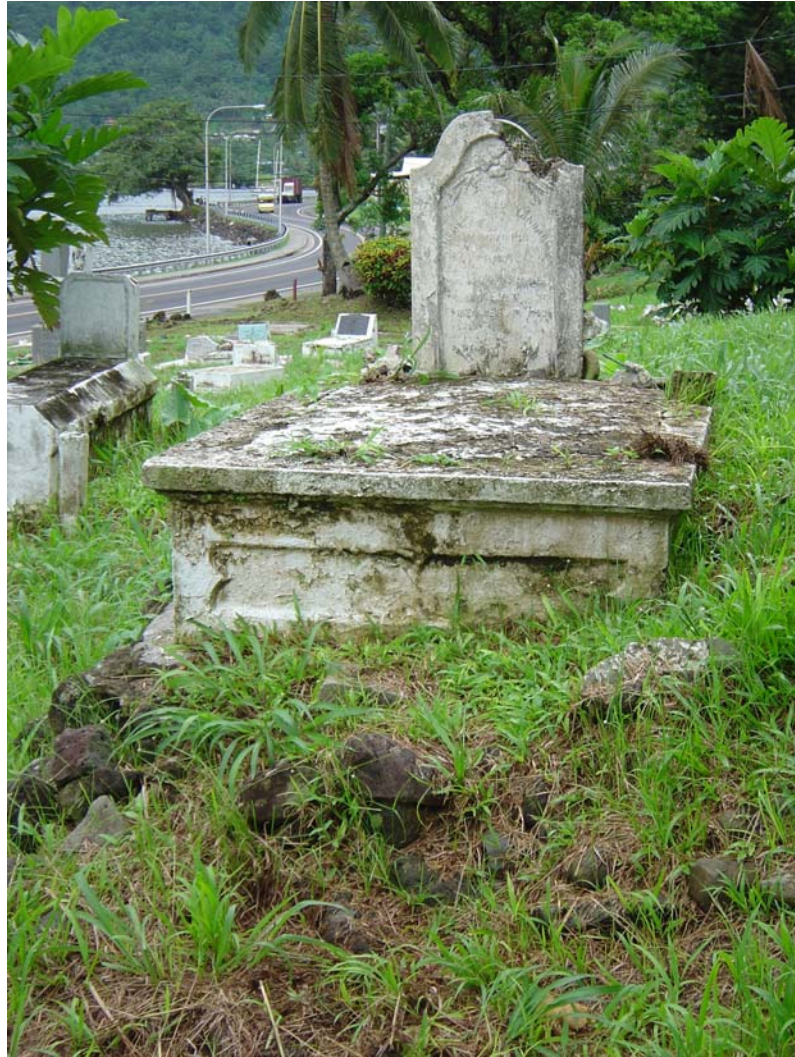
PHOTO:

EXISTING CONDITION	CONSERVATION STRATEGY
<p>POSITION: fallen <b>unstable</b> overgrown <b>tilted marker/ base</b> other _____</p> <p>DETERIORATION: <b>broken</b> <b>cracked</b> <b>losses</b> <b>flaking/sugaring</b> delaminations/detachment other _____</p> <p>SOILING: <b>biological</b> general graffiti efflorescence <b>painting</b> other</p> <p>FAILED TREATMENTS: ----- metal adhesives/coatings mortar other _____</p>	<p>POSITION: reset in ground reset to existing base resquare botom edge remove fragments in setting slot construct new base possible new base required stabilize foundation</p> <p>DETERIORATION: structural adhesion repair mortars crack fillers flowable grouts consolidation</p> <p>SOILING: chemical pressure wash poultice air abrasion</p> <p>FAILED TREATMENTS: drill/grind hand tools solvents air abrasion</p>

SUMMARY: Cover of vault cracked throughout, broken on west side. Not stable headstone broken, fragments are visible as is metal reinforcements. Sugaring and flaking in exposed concrete areas; thick white paint flaking across entire primary structure.

**hazardous/immediate action**    unstable deterioration/ASAP
