# CEMETERY SURVEY FORM

SITE NAME: Satala Naval Cemetery

LOCATION: Maoputasi County, Tutuila Island, American Samoa

PLOT IDENTIFICATION: 46

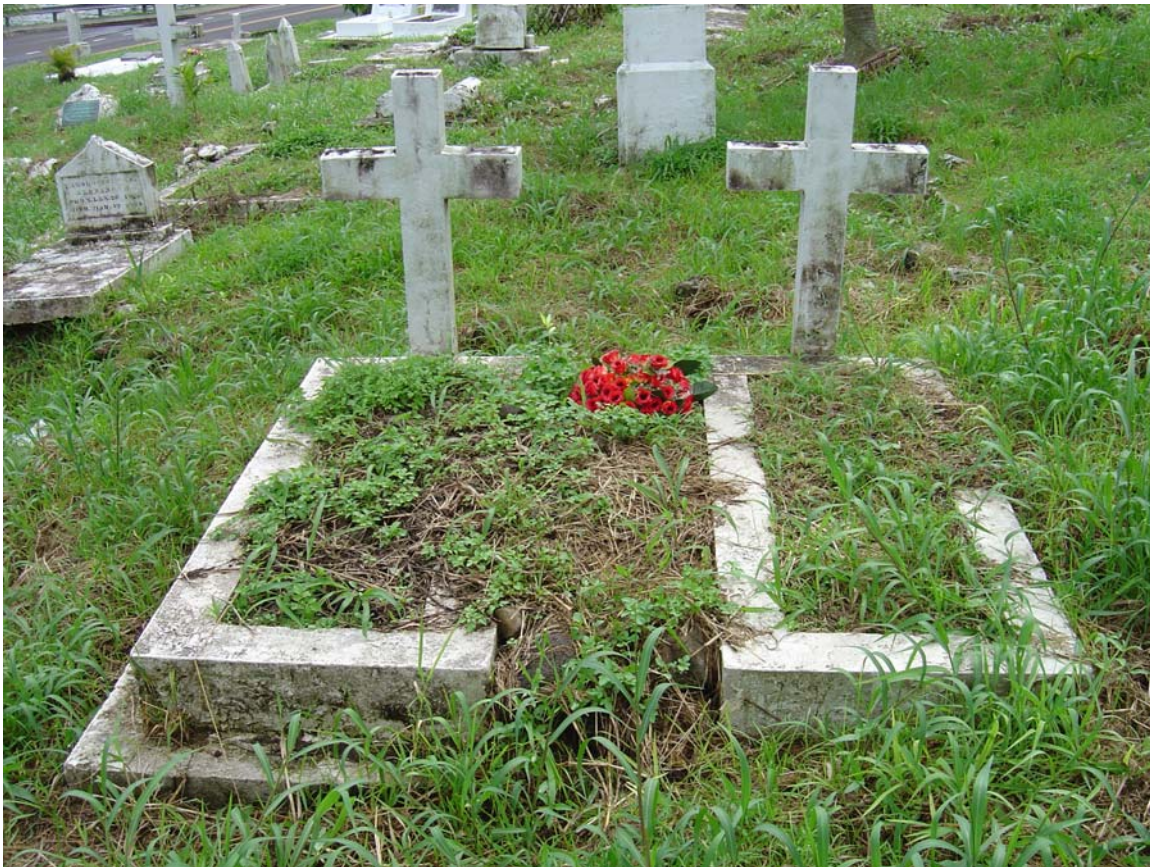
PHOTO:

EXISTING CONDITION	CONSERVATION STRATEGY
<p>POSITION: fallen unstable <b>overgrown</b> tilted marker/ base other _____</p> <p>DETERIORATION: ----- broken cracked losses flaking/sugaring delaminations/detachment other _____</p> <p>SOILING: <b>biological</b> general graffiti efflorescence <b>painting</b> other</p> <p>FAILED TREATMENTS: ----- metal adhesives/coatings mortar other _____</p>	<p>POSITION: reset in ground reset to existing base resquare botom edge remove fragments in setting slot construct new base possible new base required stabilize foundation</p> <p>DETERIORATION: structural adhesion repair mortars crack fillers flowable grouts consolidation</p> <p>SOILING: chemical pressure wash poultice air abrasion</p> <p>FAILED TREATMENTS: drill/grind hand tools solvents air abrasion</p>

SUMMARY: Double grave with two crosses and open box concrete primary structure filled with basalt cobbles. Overgrown, covered in mildew and white paint.

ongoing deterioration/treatment required 2-5 years    **re-inspect in 5 years**

**monitor**
