# CEMETERY SURVEY FORM

SITE NAME: Satala Naval Cemetery

LOCATION: Maoputasi County, Tutuila Island, American Samoa

PLOT IDENTIFICATION: 58

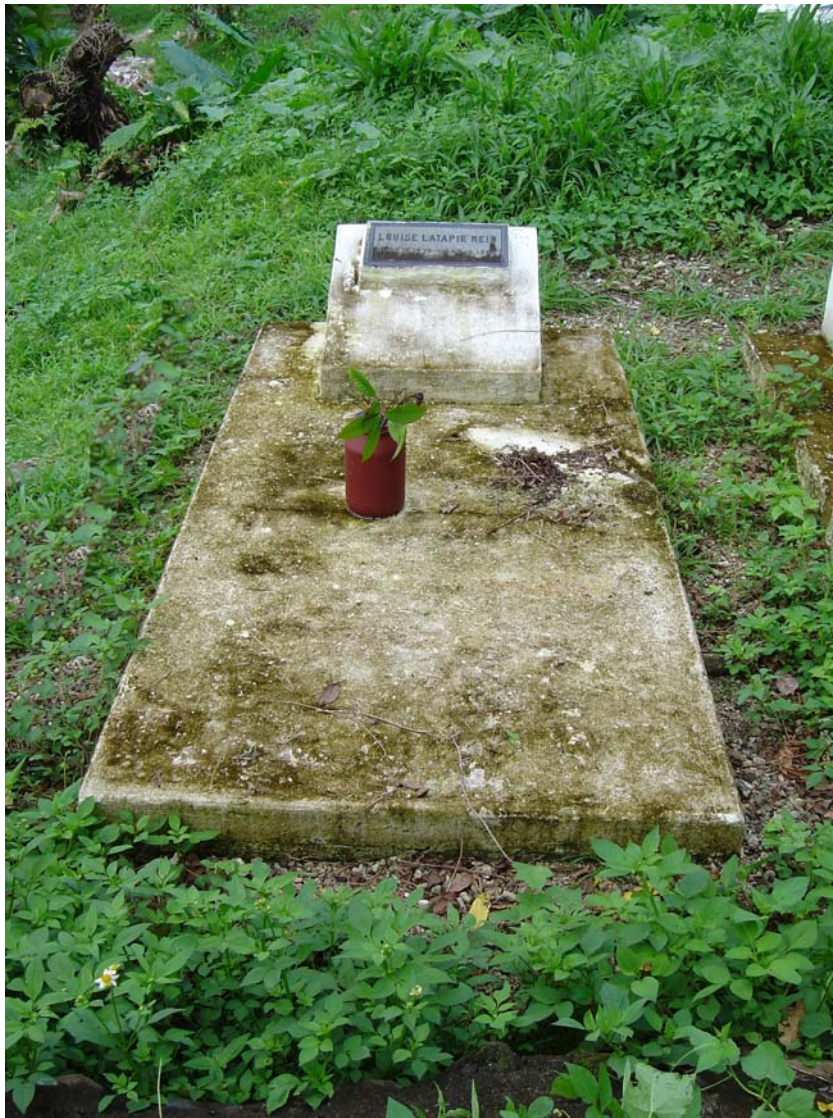
PHOTO:

SUMMARY: Grave is annually maintained by the Reid Family. Some small cracks across width of base at the middle of its length. Peeling paint and some mildew need to be removed.

ongoing deterioration/treatment required 2-5 years    **re-inspect in 5 years**
