CEMETERY SURVEY FORM

SITE NAME: Satala Naval Cemetery

LOCATION: Maoputasi County, Tutuila Island, American Samoa

PLOT IDENTIFICATION: 61

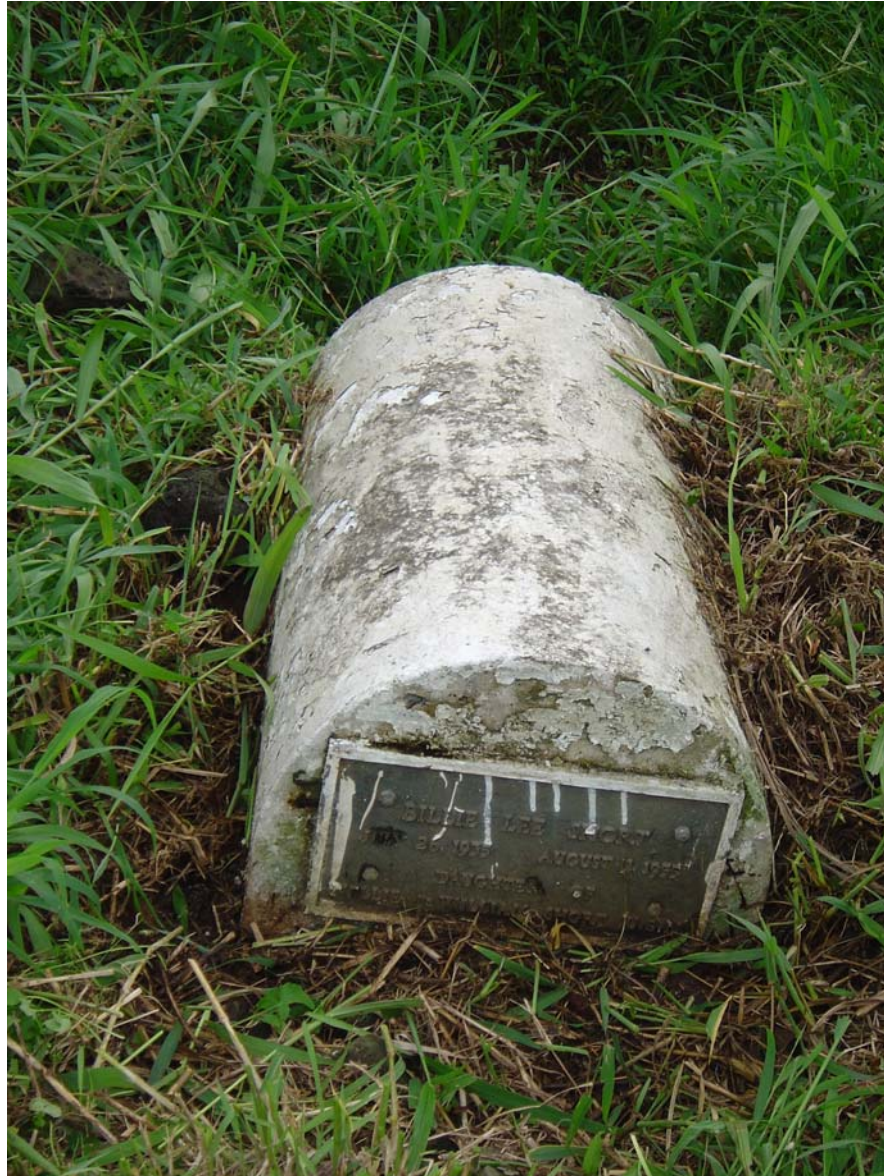
PHOTO:

EXISTING CONDITION	CONSERVATION STRATEGY
<p>POSITION:</p> <p>fallen unstable overgrown</p> <p>tilted marker/ base other <u>partially buried</u></p> <p>DETERIORATION: -----</p> <p>broken cracked losses flaking/sugaring</p> <p>delaminations/detachment</p> <p>other _____</p> <p>SOILING:</p> <p>biological general graffiti efflorescence</p> <p>painting other</p> <p>FAILED TREATMENTS: -----</p> <p>metal adhesives/coatings mortar</p> <p>other _____</p>	<p>POSITION:</p> <p>reset in ground</p> <p>reset to existing base</p> <p>resquare botom edge</p> <p>remove fragments in setting slot</p> <p>construct new base</p> <p>possible new base required</p> <p>stabilize foundation</p> <p>DETERIORATION:</p> <p>structural adhesion repair mortars</p> <p>crack fillers flowable grouts</p> <p>consolidation</p> <p>SOILING:</p> <p>chemical pressure wash</p> <p>poultice air abrasion</p> <p>FAILED TREATMENTS:</p> <p>drill/grind hand tools solvents</p> <p>air abrasion</p>

SUMMARY: Grave partially buried in flood of 2003; entire grave sinking towards SE corner; plaque is legible, need to remove paint from entire grave. Round casket sculpture.
