# CEMETERY SURVEY FORM

SITE NAME: Satala Naval Cemetery

LOCATION: Maoputasi County, Tutuila Island, American Samoa

PLOT IDENTIFICATION: 72

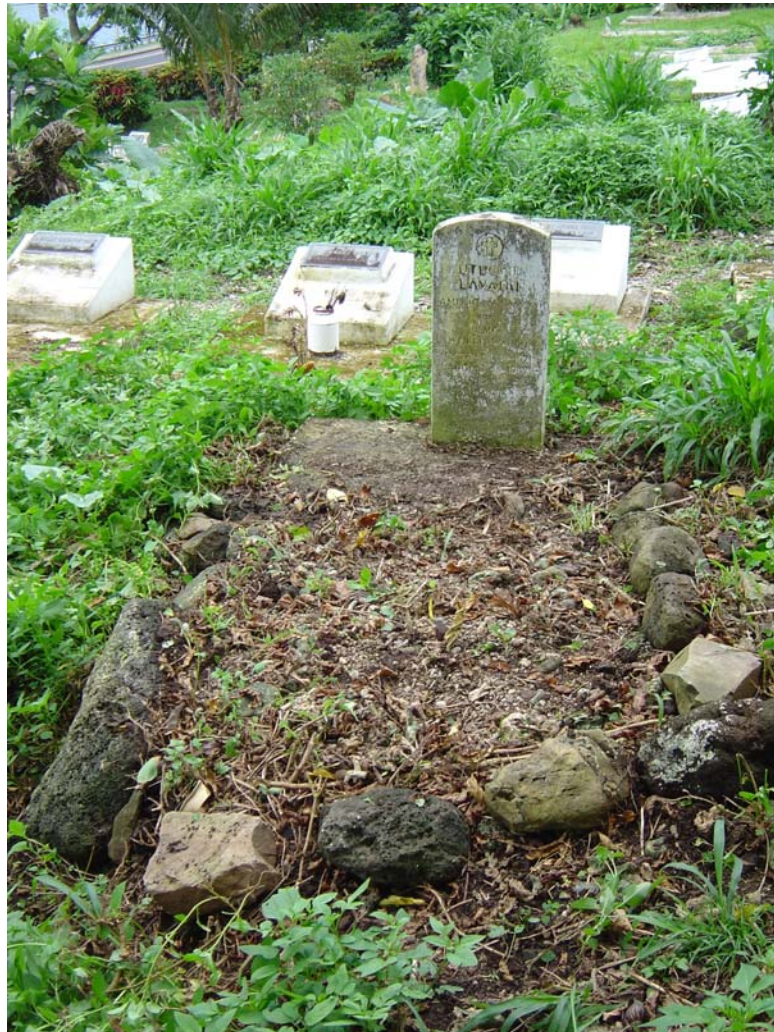
### PHOTO:

TYPE OF PRIMARY STRUCTURE (portion containing inscription): Only one rock visible,  
grave covered by plumeric trunk and other vegetation.

Grave looks recently tended; headstone sits on concrete slab that looks repaired w/ cemented rocks; E ½ of grave consists of rock outline filled with coral gravel. Paint should be cleaned up.

ongoing deterioration/treatment required 2-5 years    **re-inspect in 5 years**
