# CEMETERY SURVEY FORM

SITE NAME: Satala Naval Cemetery

LOCATION: Maoputasi County, Tutuila Island, American Samoa

PLOT IDENTIFICATION: 87

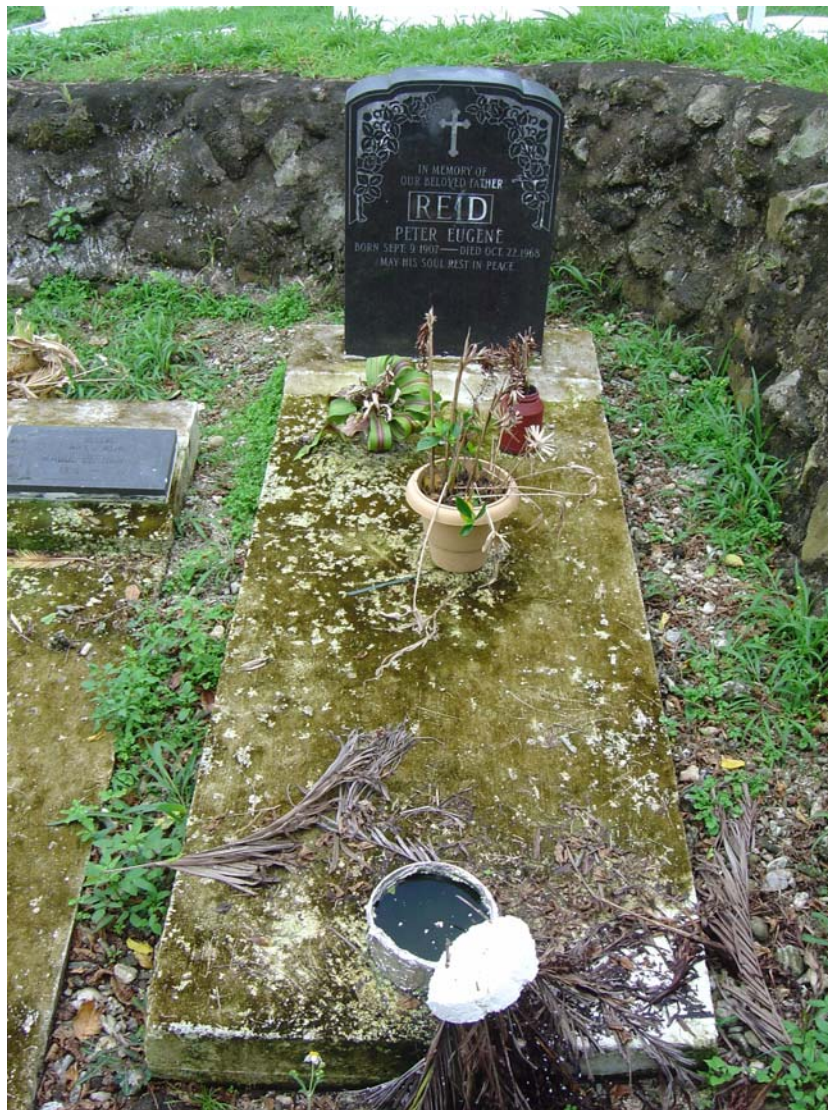
PHOTO:

SUMMARY: Grave is annually maintained by the Reid Family. Peeling paint and some mildew need to be removed. Some small crack in vault cover.
