# CEMETERY SURVEY FORM

SITE NAME: Satala Naval Cemetery (AS-25-055)

PLOT IDENTIFICATION: 94

NAME(S) OF INTERRED: Victor Peter Chanel

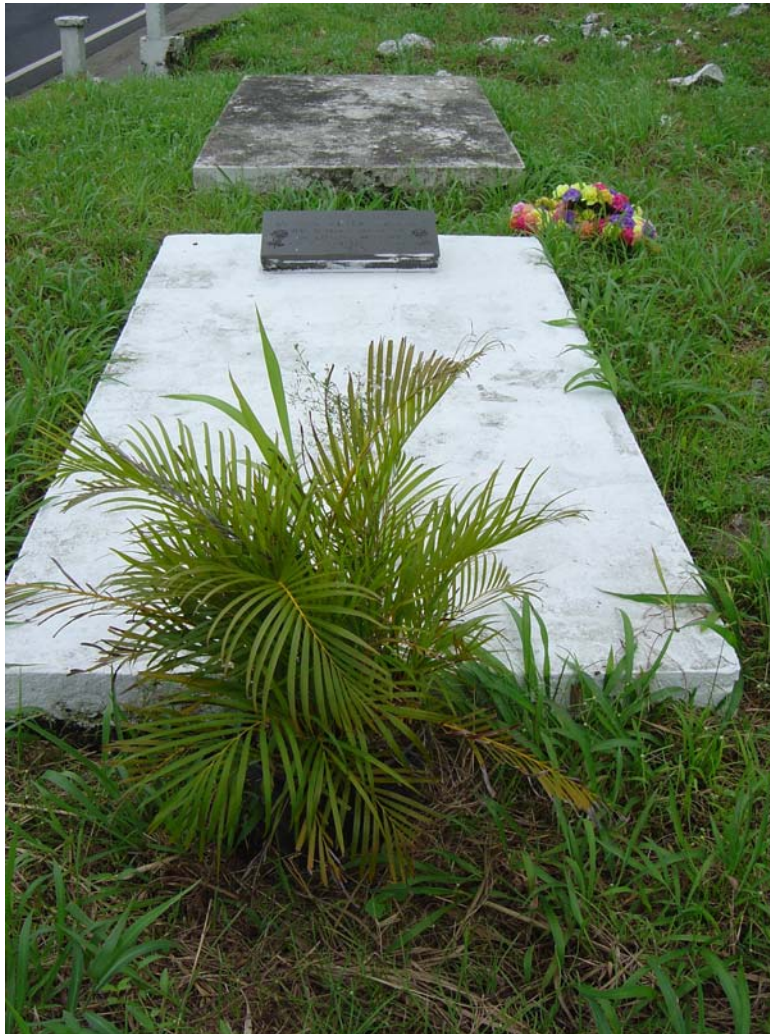
PHOTO:

SUMMARY: The concrete slab is covered in layers of thick white paint and the painted surface has mildew patches. There is some paint on the inscribed plaque. Mildew should be washed off and painted should be removed.

ongoing deterioration/treatment required 2-5 years    **re-inspect in 5 years**
