CEMETERY SURVEY FORM

SITE NAME: Satala Naval Cemetery (AS-25-055)

LOCATION: Maoputasi County, Tutuila Island, American Samoa

PLOT: 97 and 97A

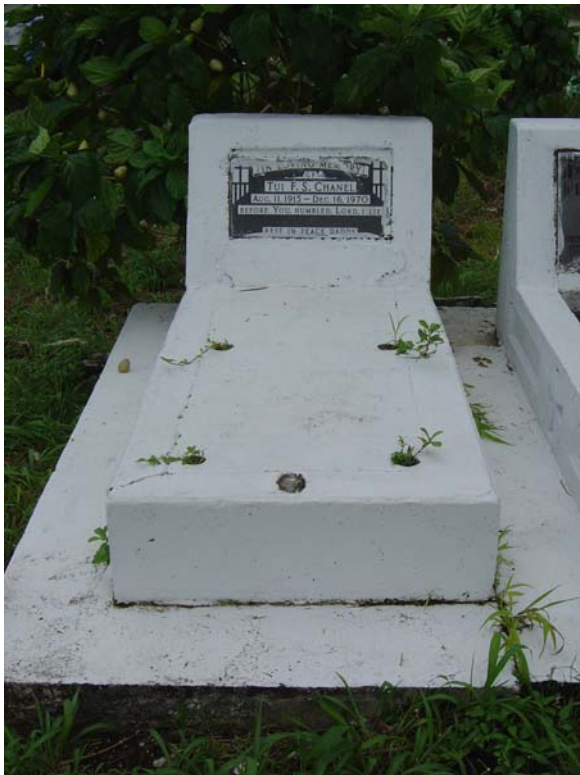
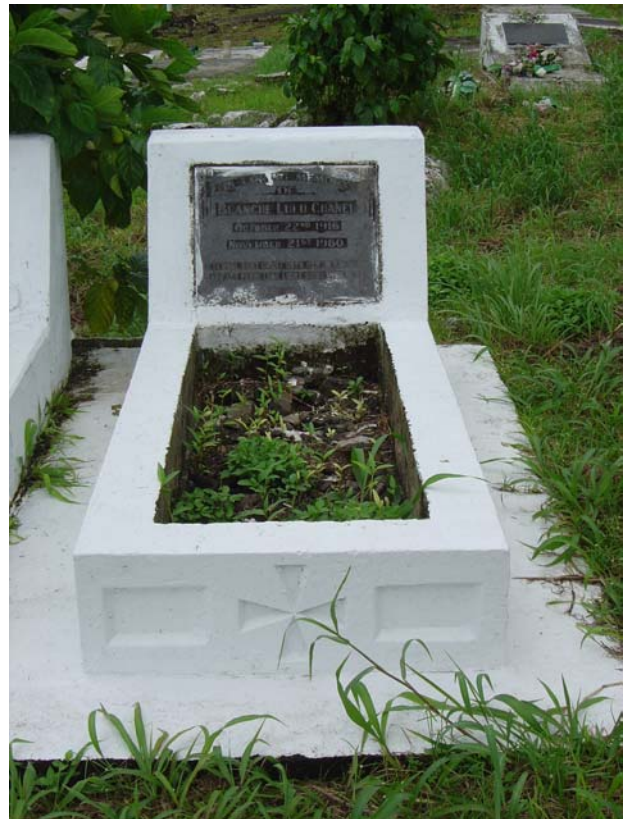
PHOTO:

SUMMARY: The grave consists of two interments laid side by side.

The Tui grave is a closed top bedstead with 4 embedded vases in the surface. The base is cut short on the north side to fit against the Blanche grave. The Blanche grave is an open bedstead with incised rectangles and crosses around the bedsides. The inside is filled with waterworn basalt cobbles.

Both graves are covered in layers of thick white paint and the painted surface has mildew patches. There is also some cracking in the surface with vegetation growing out.

Mildew should be washed off and painted should be removed. Cracks should be filled.
