# CEMETERY SURVEY FORM

SITE NAME: Satala Naval Cemetery (AS-25-055)

PLOT IDENTIFICATION: 98

NAME(S) OF INTERRED: Joseph G. Hoffman

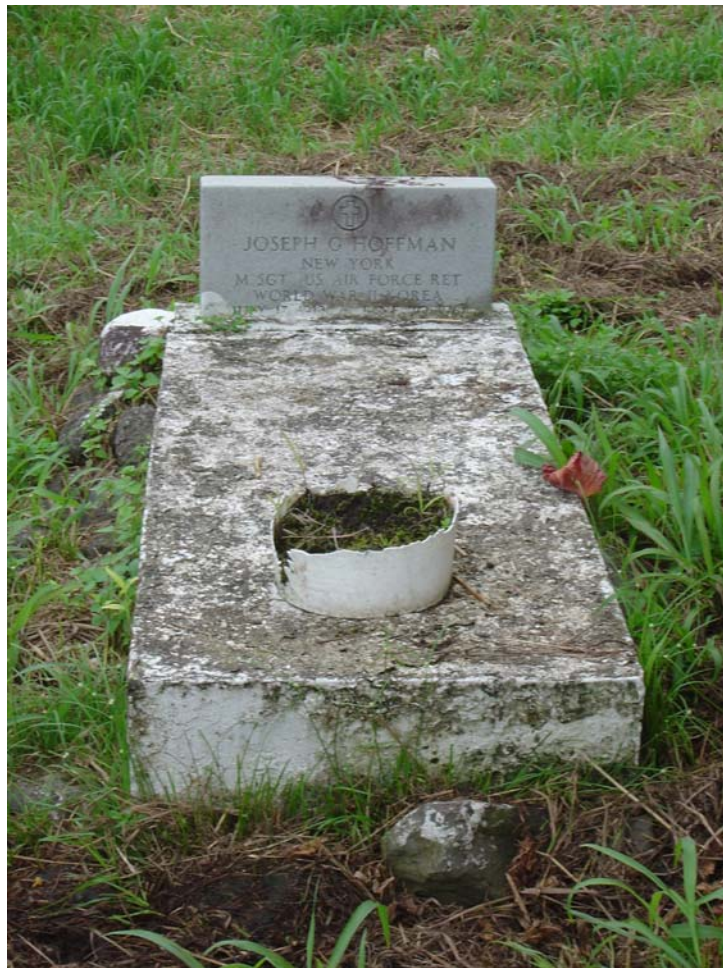
PHOTO:

EXISTING CONDITION	CONSERVATION STRATEGY
<p><b>POSITION:</b> fallen unstable <b>overgrown</b> tilted marker/ base other _____</p> <p><b>DETERIORATION:</b> <b>broken</b> cracked losses flaking/sugaring delaminations/detachment other _____</p> <p><b>SOILING:</b> <b>biological</b> general graffiti efflorescence <b>painting</b> other</p> <p><b>FAILED TREATMENTS:</b> metal adhesives/coatings mortar other _____</p>	<p><b>POSITION:</b> reset in ground reset to existing base resquare botom edge remove fragments in setting slot construct new base possible new base required stabilize foundation</p> <p><b>DETERIORATION:</b> structural adhesion repair mortars crack fillers flowable grouts consolidation</p> <p><b>SOILING:</b> chemical pressure wash poultice air abrasion</p> <p><b>FAILED TREATMENTS:</b> drill/grind hand tools solvents air abrasion</p>

SUMMARY: The headstone base portion of the primary structure is separated from the main body. The primary structure is covered in flaking, peeling layers of white paint and patches of mildew. There is some biological staining on the headstone with some white paint partially obscuring the birth and death dates. The curb enclosure is overgrown with grass and weeds. Mildew should be washed off and painted should be removed. The headstone portion should be reset to close the gap and the remaining crack should be filled.
