# CEMETERY SURVEY FORM

SITE NAME: Satala Naval Cemetery (AS-25-055)

PLOT IDENTIFICATION: 102

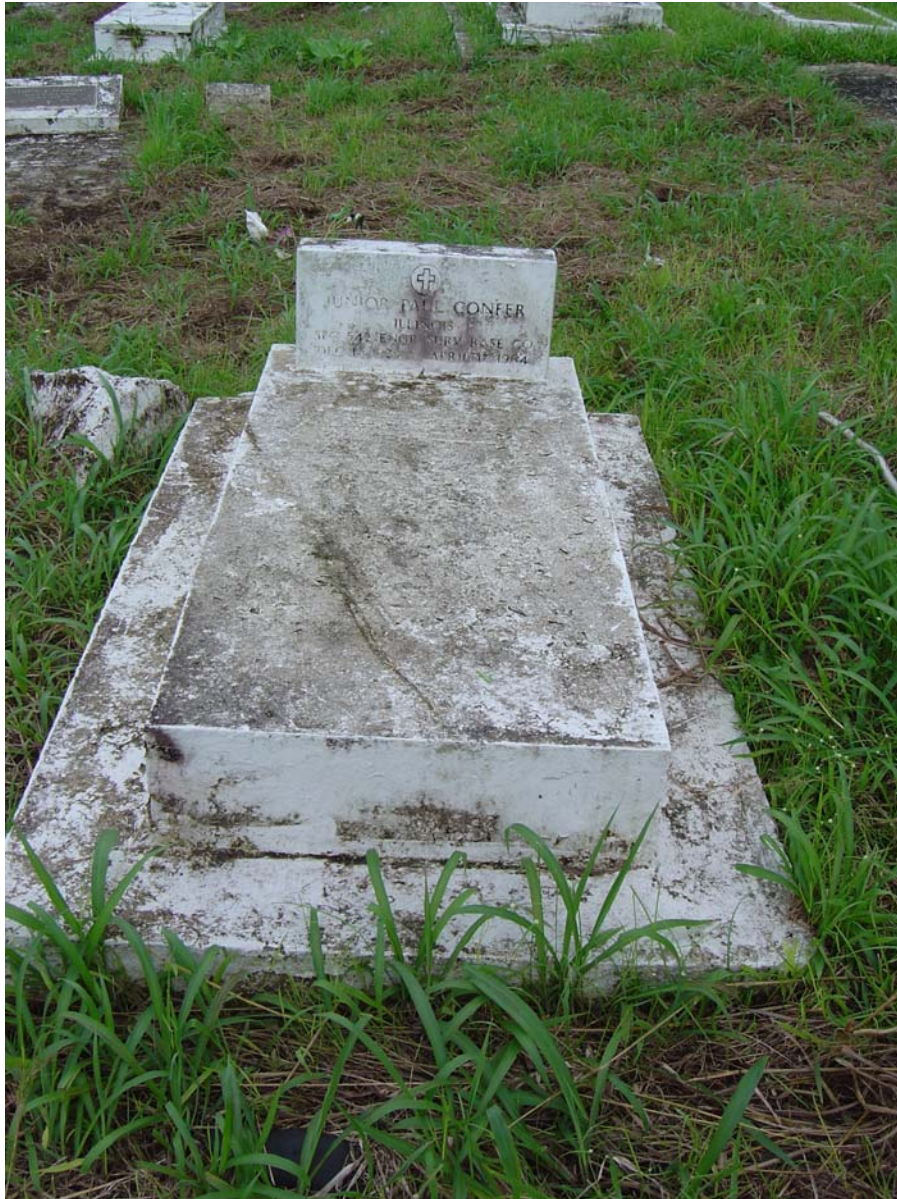
PHOTO:

EXISTING CONDITION	CONSERVATION STRATEGY
<p>POSITION:</p> <p>fallen unstable <b>overgrown</b></p> <p>tilted marker/ base other _____</p> <p>DETERIORATION: -----</p> <p>broken cracked losses flaking/sugaring</p> <p>delaminations/detachment</p> <p>other _____</p> <p>SOILING:</p> <p><b>biological</b> general graffiti efflorescence</p> <p><b>painting</b> other</p> <p>FAILED TREATMENTS: -----</p> <p>metal adhesives/coatings mortar</p> <p>other _____</p>	<p>POSITION:</p> <p>reset in ground</p> <p>reset to existing base</p> <p>resquare botom edge</p> <p>remove fragments in setting slot</p> <p>construct new base</p> <p>possible new base required</p> <p>stabilize foundation</p> <p>DETERIORATION:</p> <p>structural adhesion repair mortars</p> <p>crack fillers flowable grouts</p> <p>consolidation</p> <p>SOILING:</p> <p>chemical pressure wash</p> <p>poultice air abrasion</p> <p>FAILED TREATMENTS:</p> <p>drill/grind hand tools solvents</p> <p>air abrasion</p>

SUMMARY: White paint and mildew need to be removed.

ongoing deterioration/treatment required 2-5 years    **re-inspect in 5 years**

**monitor**
