# CEMETERY SURVEY FORM

SITE NAME: Satala Naval Cemetery

PLOT IDENTIFICATION: 70

NAME(S) OF INTERRED: CHARLIE UHRLE

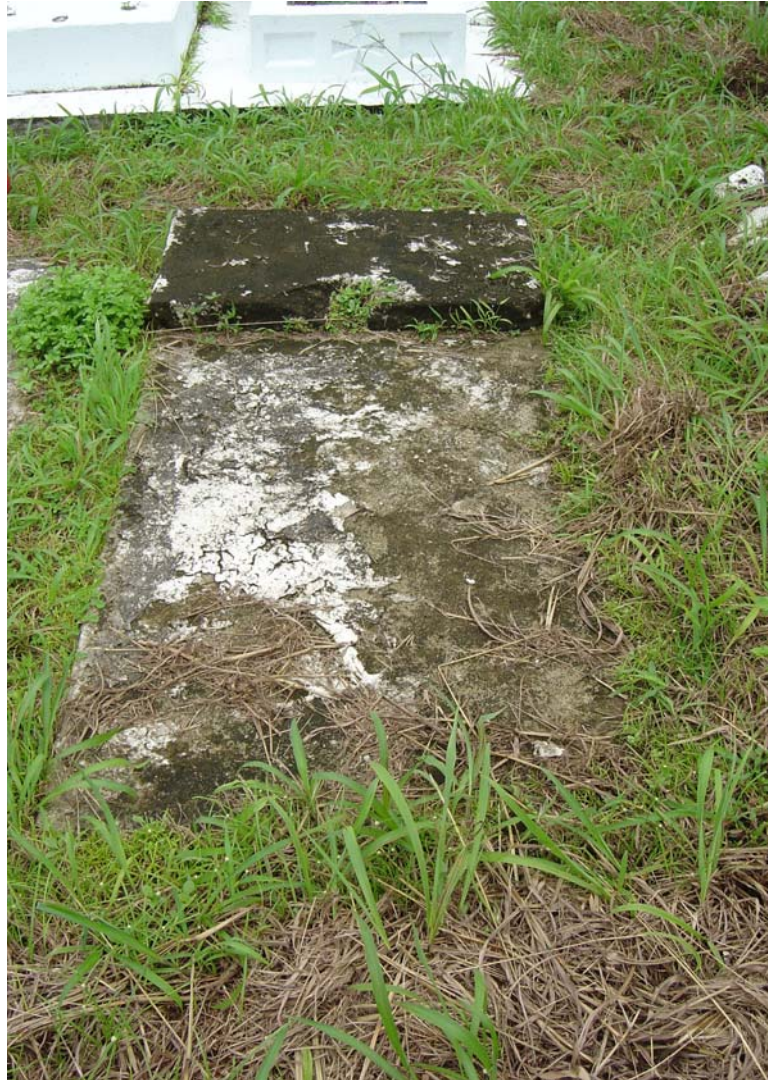
PHOTO:

TYPE OF PRIMARY STRUCTURE (portion containing inscription): Only one rock visible, grave covered by plumeric trunk and other vegetation.

EXISTING CONDITION	CONSERVATION STRATEGY
<p>POSITION: fallen unstable <b>overgrown</b> <b>tilted marker/ base</b> other _____</p> <p>DETERIORATION: <b>broken</b> <b>cracked</b> losses flaking/sugaring delaminations/detachment other _____</p> <p>SOILING: <b>biological</b> general graffiti efflorescence <b>painting</b> other</p> <p>FAILED TREATMENTS: metal adhesives/coatings mortar other _____</p>	<p>POSITION: reset in ground reset to existing base resquare botom edge remove fragments in setting slot construct new base possible new base required stabilize foundation</p> <p>DETERIORATION: structural adhesion repair mortars crack fillers flowable grouts consolidation</p> <p>SOILING: chemical pressure wash poultice air abrasion</p> <p>FAILED TREATMENTS: drill/grind hand tools solvents air abrasion</p>

SUMMARY: Headstone may have collapsed onto primary slab.

Broken pieces out of both and each covered in flaking white paint, moss, and mildew.

Vegetation growing out of cracks.

hazardous/immediate action **unstable deterioration/ASAP**
